ASSESSMENT OF INTEGRATED GREEN INFRASTRUCTURE-BASED  
STORMWATER CONTROLS IN SMALL TO LARGE SCALE DEVELOPED  
URBAN WATERSHEDS

A DISSERTATION

Submitted in partial fulfillment of the requirements  
for the degree of Doctor of Philosophy  
in the Department of Civil, Construction, and Environmental Engineering  
in the Graduate School of  
The University of Alabama

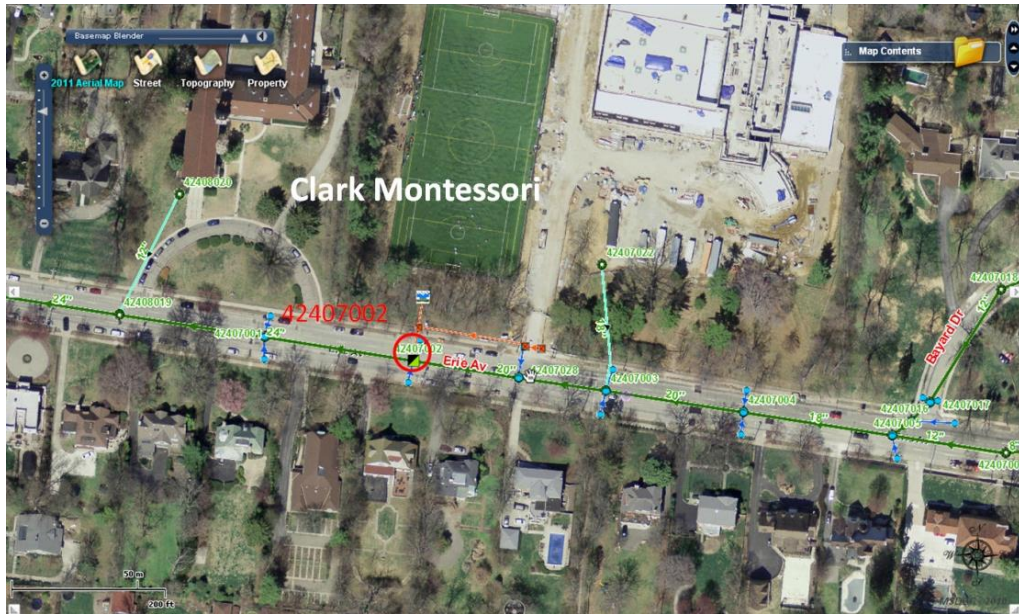
Figure 3.8. Flow monitoring location (red circle) at Clark Montessori High School

**3) Clark Montessori High School:** This high school project area is surrounded by an urban residential area, on Erie Avenue, east of downtown Hyde Park in Cincinnati, Ohio. One monitoring location measures the separate stormwater flows in a 20 in pipe from this newly constructed area before its discharge into the combined sewer system. (Figure 3.8)

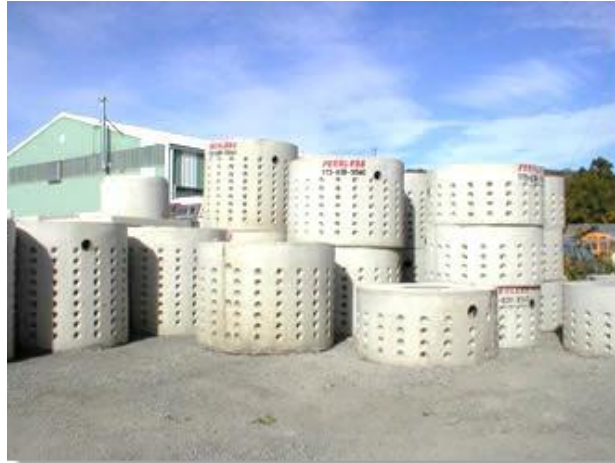
Figure 3.9. Peerless Concrete Products, Butler, NJ, supplies the dry wells to many of the sites in Millburn (photo from <http://www.peerlessconcrete.com/>)

The Millburn Township Development Regulations list dry wells as one option for minimizing increased flows associated with new (and increased) development. A dry well is a subsurface infiltration stormwater disposal practice that receives stormwater runoff from surrounding areas for subsurface disposal to shallow groundwater. Most of the dry wells in the Township of Millburn are precast concrete structures (Figure 3.9), with open bottoms resting on 0.6 m (2 ft) crushed stone layers and with 0.6 m (2 ft) of crushed stone surrounding the dry wells.

Most of the dry wells receive water directly from roof drain leaders or by storm drain inlets located in driveways or small parking lots. Some also have grated covers and receive surface runoff from the surrounding lawn or paved areas.

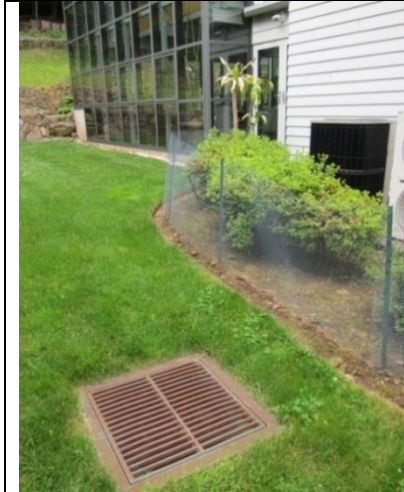
Figure 3.10. Typical Millburn dry well locations.

Backyard dry well showing lawn area also as a source.

Eleven dry wells were monitored for water levels during periods ranging from two months to one year, or by controlled tests using township water from fire hydrants. Four rain gauges were also installed near the dry wells. Figure 3.10 shows typical dry well installations. Figure 3.11 is a large-scale map showing the locations of the study areas in the Township of Millburn.

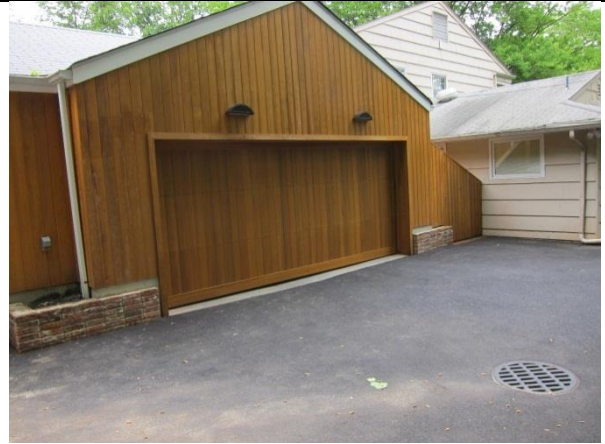
Backyard dry well showing driveway runoff also as a source.

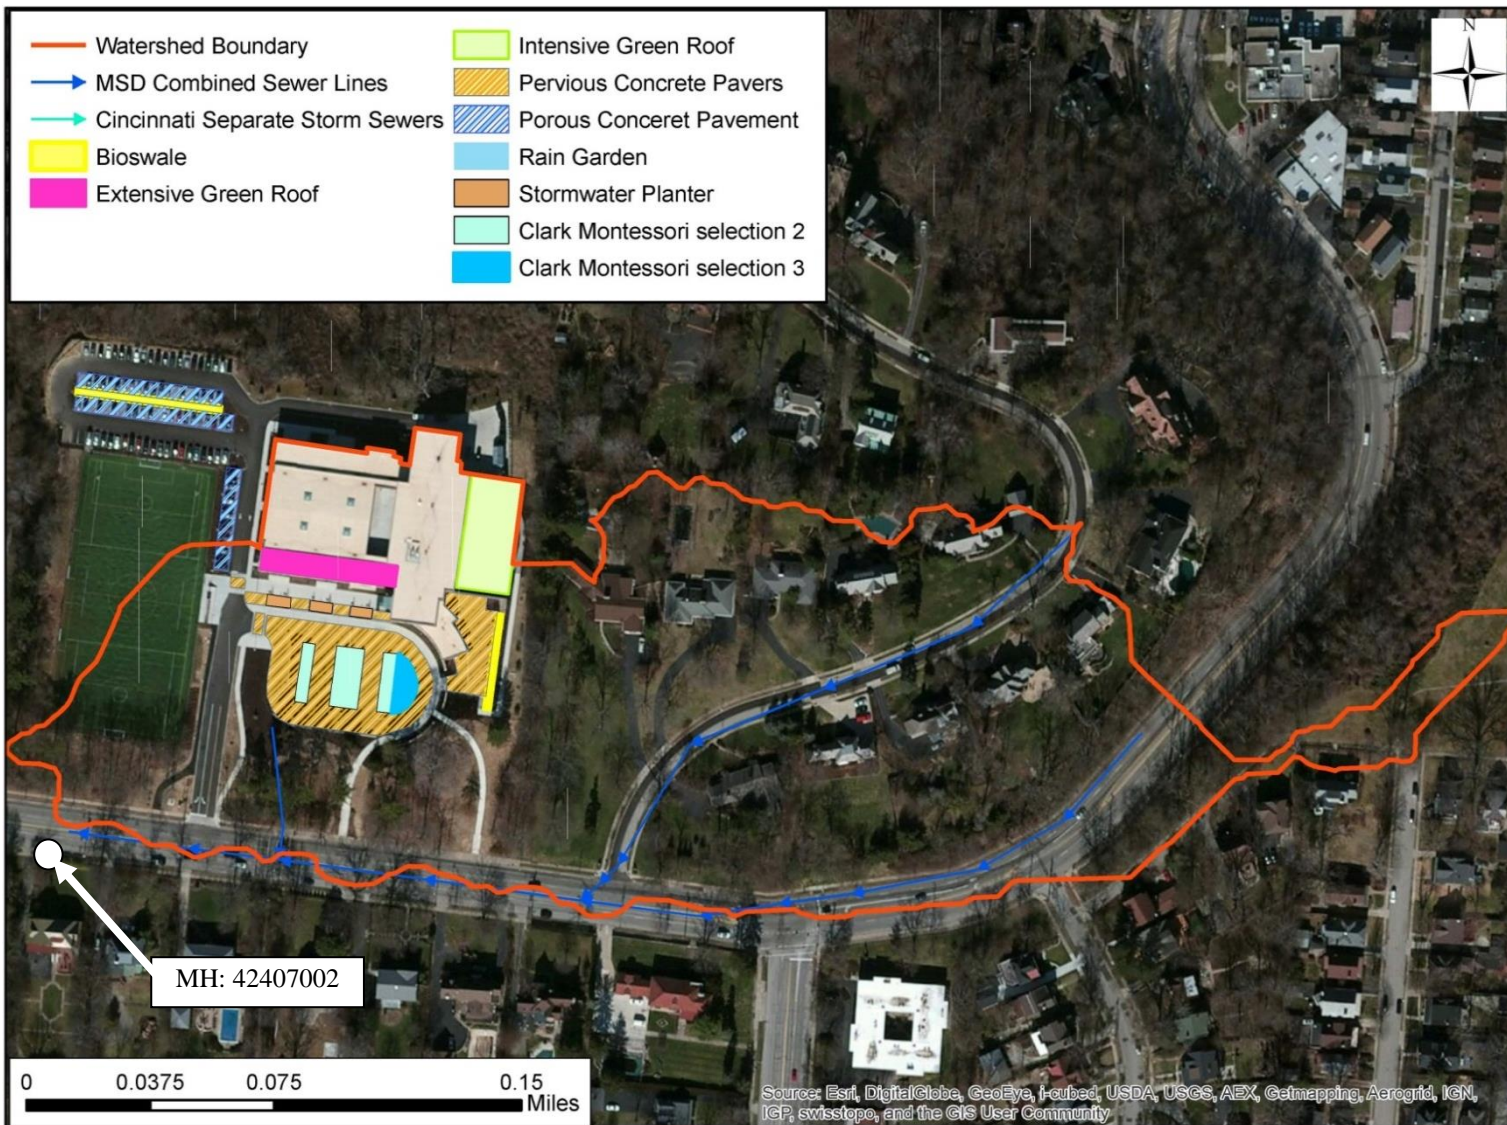
Figure 3.18. Location of GI stormwater controls at Clark Montessori High School

**3) Clark Montessori High School:** This site has various green stormwater controls including green roofs, permeable pavement, and bioretention facilities (bioswales, stormwater planters, and a rain garden). Green roofs comprise 9,200 square feet of intensive roof, which has a permanent sub-surface irrigation system, and 5,500 square feet of extensive roof. In addition, the site has 13,000 square feet of pervious concrete and 2,000 square feet of permeable pavers with no underdrains. Bioretention facilities include three stormwater planters, two bioswales, and one rain garden. Figure 3.18 is a map of the location of GI stormwater controls at Clark Montessori High School.

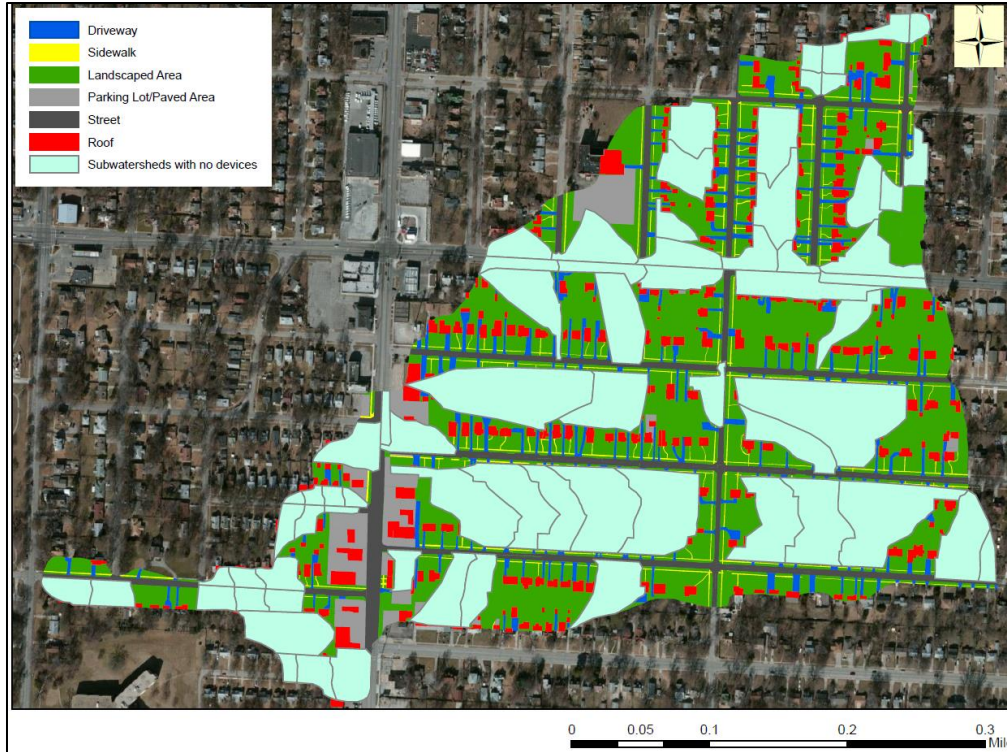
Figure 3.20. Map of test (pilot) area showing surface characteristics of areas receiving stormwater treatment.

Table 3.11 summarizes the source areas for each of the controlled and uncontrolled subareas in the test (pilot) watershed. About 45% of the complete watershed does not receive any control and drains directly into the combined sewer, and about 55% of the area is treated. The following table and associated maps indicate that the areas being treated are generally closer to the streets (including sidewalks, most of the driveways, and many of the roofs). The untreated areas have a greater portion of landscaped areas that drain through yard drains directly into the combined sewer system.

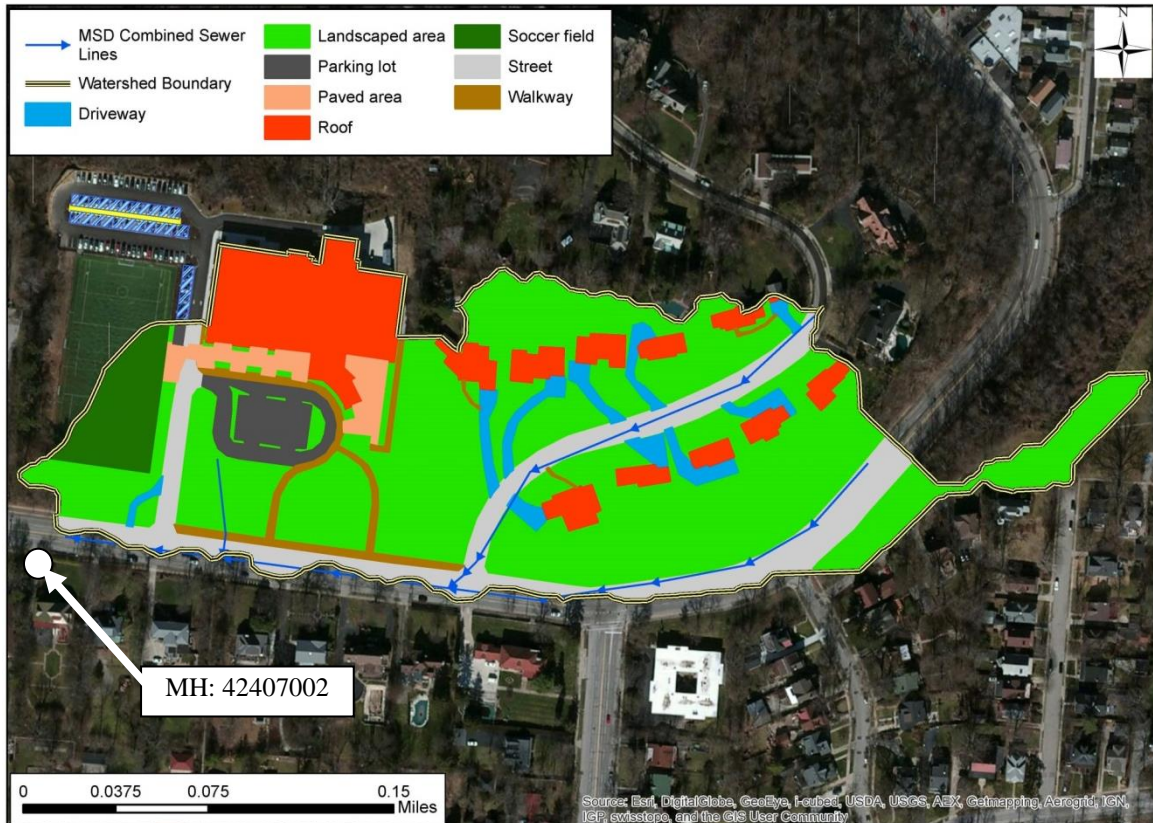
Figure 3.25. Map of Clark Montessori High School area showing main surface characteristics.

The drainage area for the Clark Montessori High School above the monitoring location is approximately 14.8 acres, mostly consists of the high school's landscaped areas (58%), roofs (13.5%), and streets (13.4%) (Table 3.16, and Figure 3.25), and the upstream residential area.

Land Cover type	Area (ft <sup>2</sup> )	Area (%)
Driveway	22,842	3.6
Landscaped area	369,455	57.5
Parking lot	22,082	3.4
Paved area	15,026	2.3
Roof	86,624	13.5
Soccer Field	25,867	4.0
Street	86,134	13.4
Walkway	14,956	2.3
Total	642,986	100.0

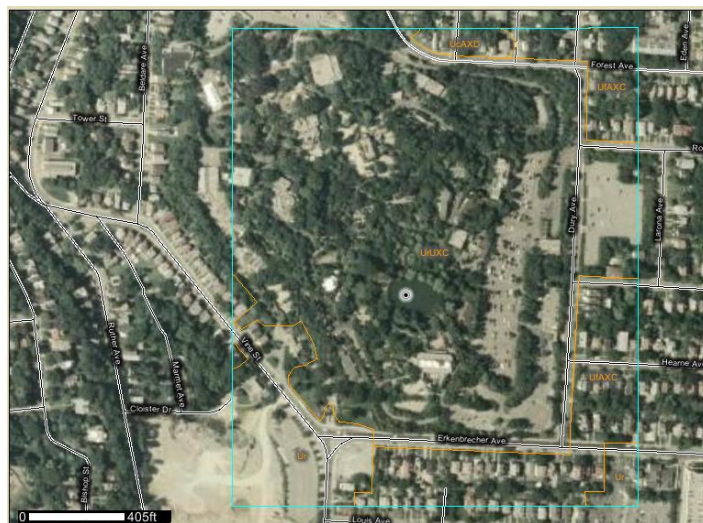
Figure 3.30. Soil Group Index for the Cincinnati Zoo area (<http://websoilsurvey.nrcs.usda.gov/app/WebSoilSurvey.aspx>)

All study areas in the Cincinnati, OH locations including Cincinnati State Technical and Community, Cincinnati Zoo, and Clark Montessori High school are mapped as having UrUXC—Urban land-Udorthents complex, with 0 to 12 percent slopes (Figures 3.29 to 3.31). Soils in this group have high to very high runoff potential when thoroughly wet. Drainage class and other properties of this soil type have not been rated.

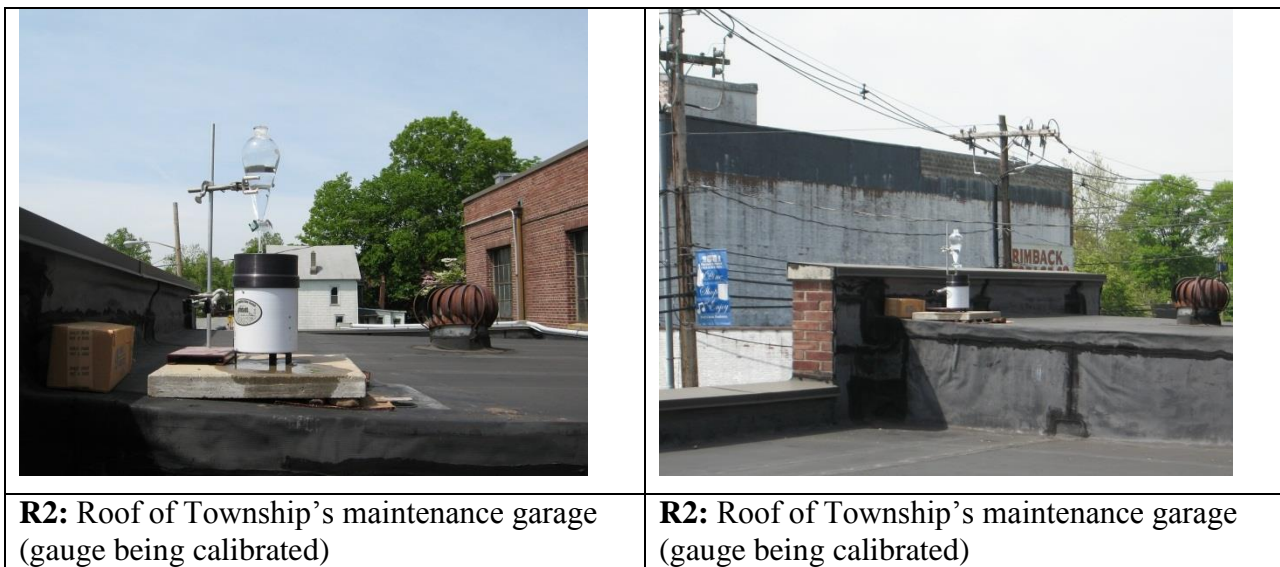
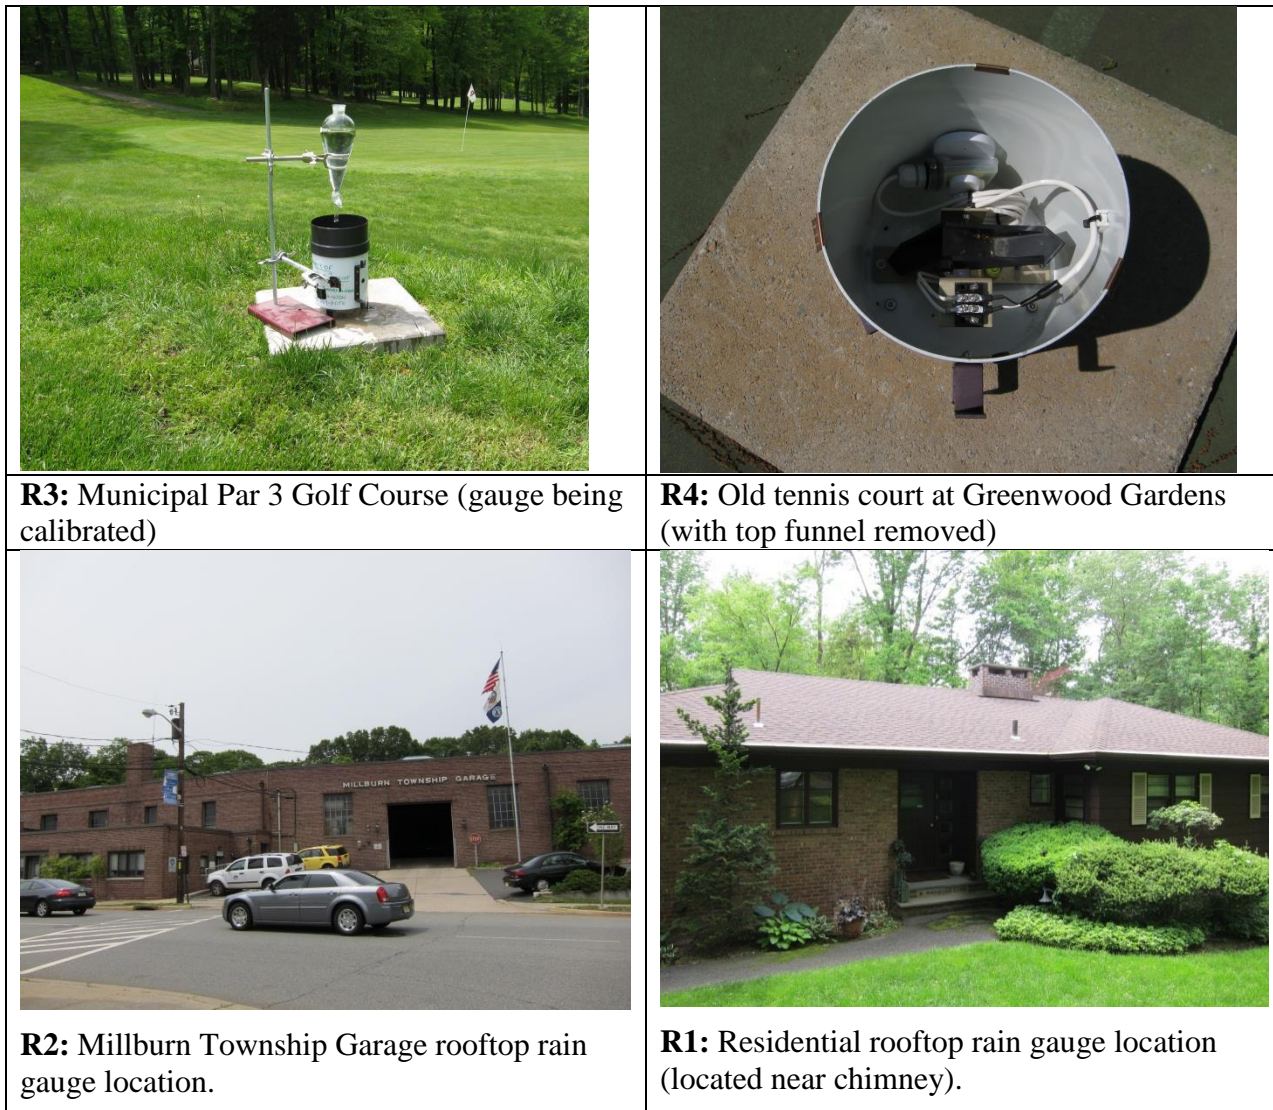
Figure 4.2. Photos of rain gauges (R1, R2, and R3 are shown during site calibration).

Four rain gauges were installed in the study area for this project (HOBO® data logging rain gauge data logger). The rain gauges are battery-powered rainfall data collection and recording systems which included a HOBO® Pendant Event data logger integrated into a standard 8 inch tipping-bucket rain gauge. Table 4.1 represents a list of the locations of the four rain gauges that were installed in the study area. Figure 4.2 shows photos of the rain gauges (with some undergoing calibration).

R1	Private house on top of chimney slab at 1 Delwick Lane - Calibrated and launched at 14:00 on 5/22/09
R2	Roof of Township’s maintenance garage on Essex Rd - Calibrated and launched at 12:00 on 5/13/09.
R3	Municipal Par 3 Golf Course on White Oak Ridge Rd - Calibrated and launched at 16:00 on 5/13/09.
R4	Old tennis court at Greenwood Gardens on Old Short Hills Rd – Calibrated and launched at 16:00 on 5/6/09.

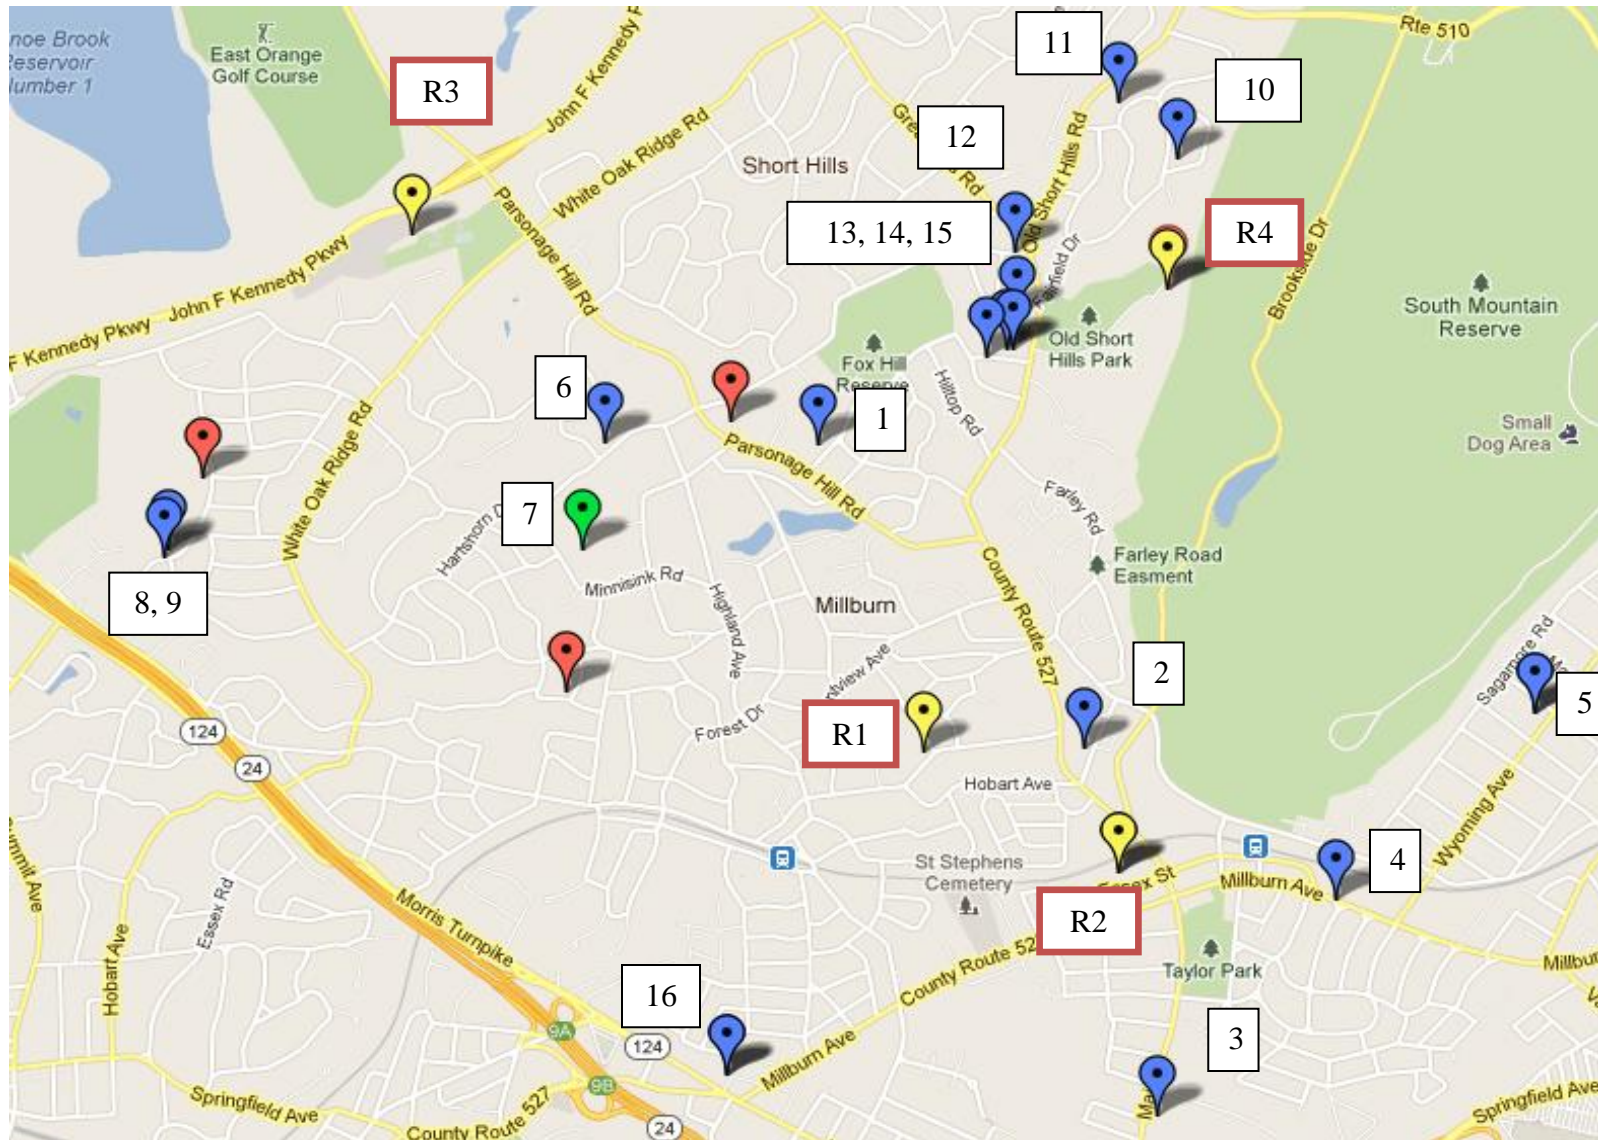
Figure 4.4. Location of dry wells (blue icons), rain gauges (yellow icons), and water quality samplers (red icons for dry wells and green icon for cistern)(source: maps.google.com).

Figure 4.4 shows the locations of the rain gauges and the monitoring locations, while Table 4.2 lists the monitoring sites and corresponding closest rain gauge location. The rain gauges provided information about the start time, end time, duration, depth, peak and average intensity of each rain event. Each separate rain event had at least 6 hr of no rain before and after the recorded rainfall. The rain information corresponding to the infiltration data is summarized for each infiltration event monitored, as shown in Table 4.3 and Figure 4.3. The rainfall graphs and information are presented in Appendix D, along with the detailed infiltration information.

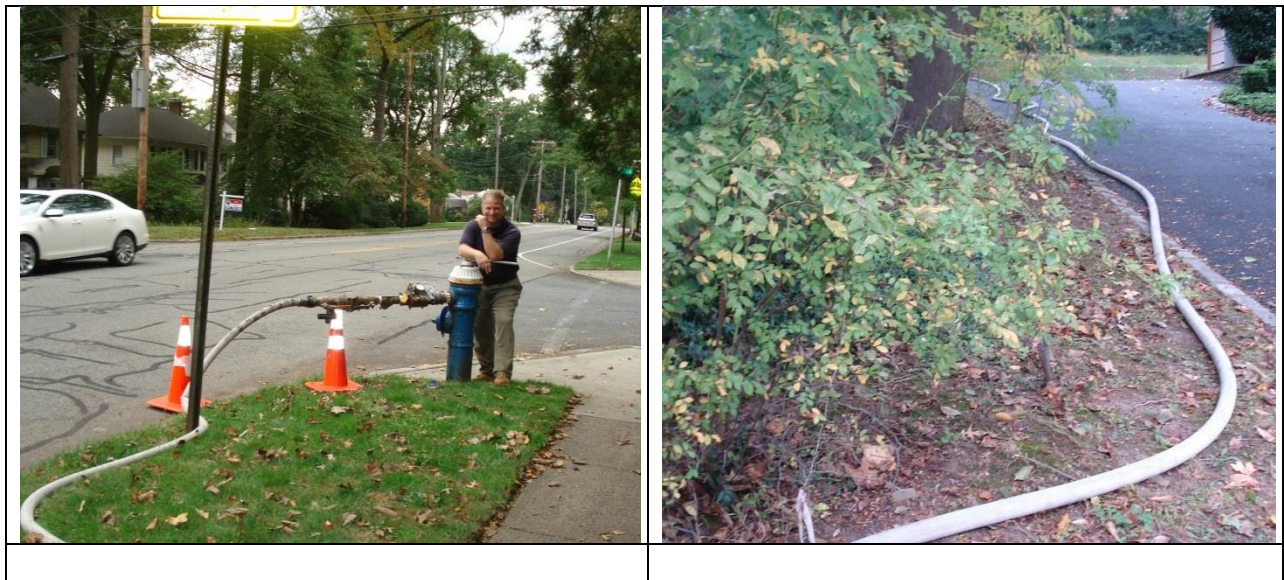
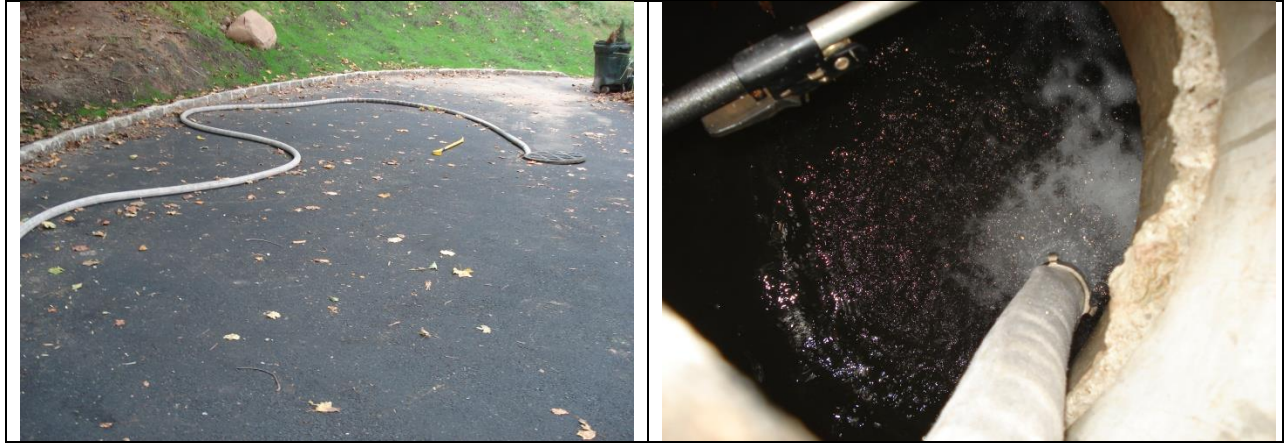
Figure 4.5. Infiltration studies for a dry well located at 383 Wyoming: filling the dry well with water from the fire hydrant and recording the fall of water level.

Initial infiltration studies were conducted by quickly filling selected dry wells with water from township fire hydrants and recording the subsequent fall of the water levels. These infiltration studies were performed after at least a 72 hr dry period. The photographs in Figure 4.5 show the process of filling the dry well with the township fire hydrant water at one of the test sites. Table 4.4 describes the township water infiltration tests for the seven selected sites.

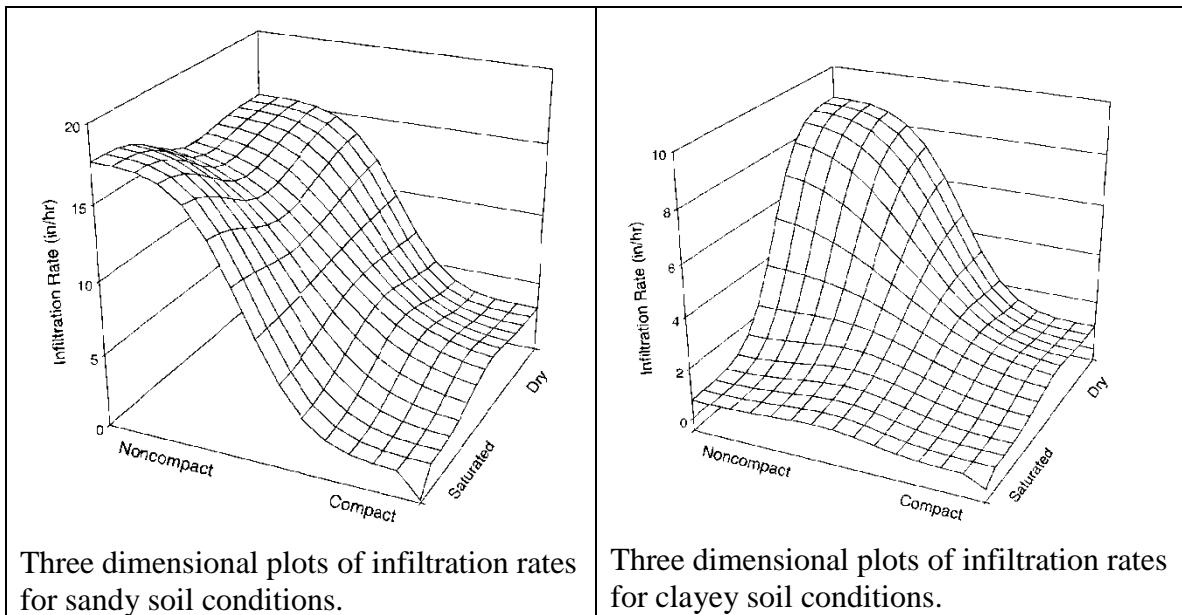
Figure 4.6. Effects of soil moisture and soil compaction on infiltration rates (Pitt *et al.* 1999).

Since the early 1990s, Pitt et al. (1999) has conducted a series of laboratory and field tests on soils covering a wide range of soil textures, densities, and stiffness. As shown in Figure 4.6, these field tests highlighted the importance of compaction on the infiltration rate of soils. For sandy soils, minimal effects are seen associated with antecedent moisture conditions compared to soil compaction. For the clayey soils, both the compaction level and antecedent moisture conditions are likely important in determining the infiltration rate. Table 4.8 summarizes the Horton equation coefficients for these urban soils, showing the dramatic effect soil density has on the infiltration characteristics.

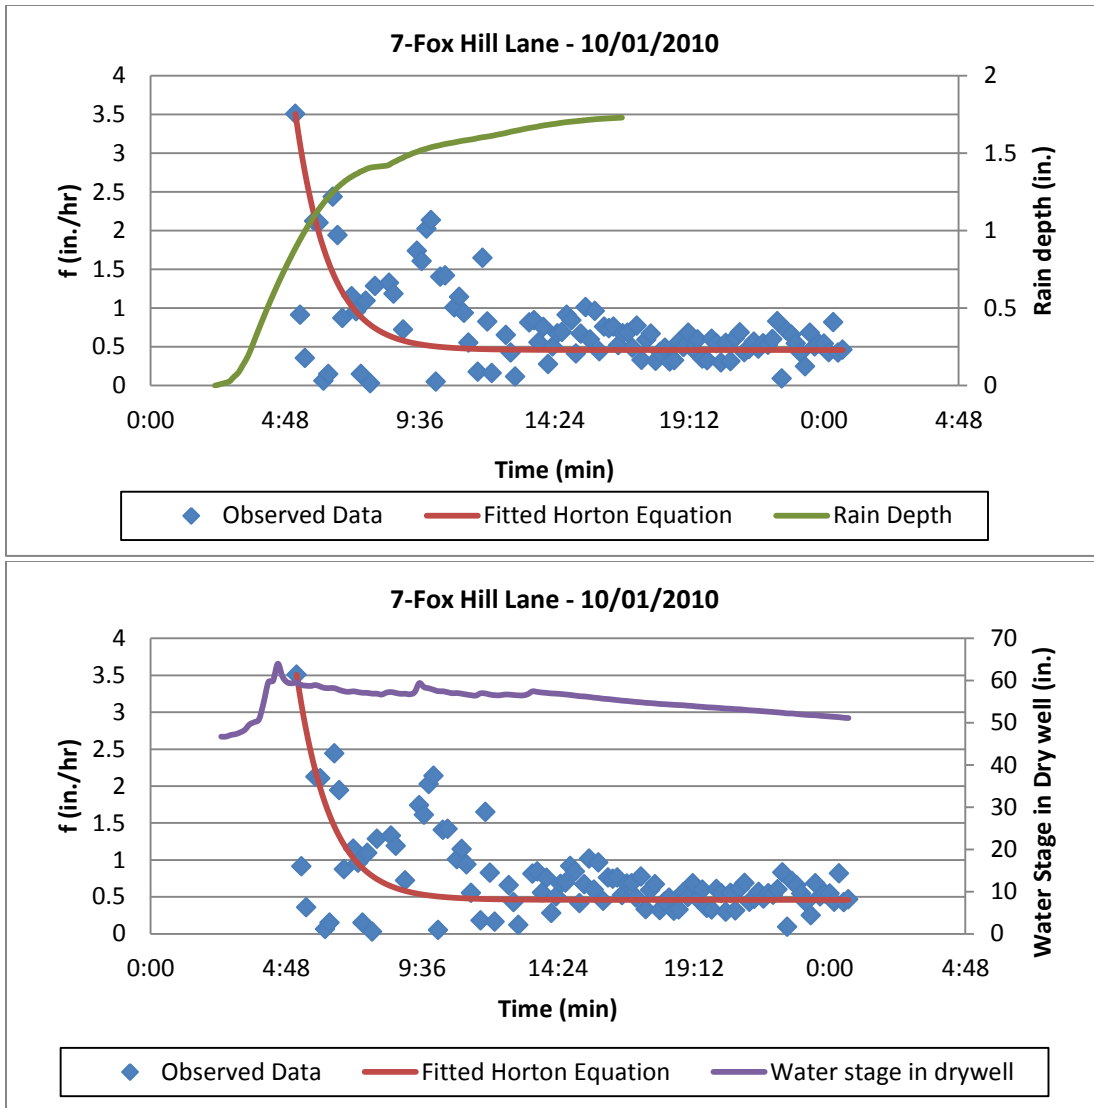
Figure 4.7 Example of observed data, fitted Horton equation, rain depth, and water stage in a dry well for a single rain event in a selected dry well. (1 in/hr = 25.4 mm/hr)

Figure 4.7 shows the observed infiltration rates and the fitted Horton equation parameter values for the dry well located at 7 Fox Hill Ln, Millburn, NJ, as an example. Graphs are for one single actual rain event representing observed data, fitted Horton equations, rain depths, and the water stages in the dry well. The remaining observed data along with fitted Horton graphs for each dry well and each event are presented in Appendix C. Some initial rates were very large, but decreased quickly with time. As shown on Figure 4.7 the variability of the infiltration rates is heterogeneous and is higher in the beginning of the infiltration process. After equilibrium had been reached there is less variation in infiltration rates. Basic statistical analyses, including average, minimum, maximum, standard deviation, and COV are included for all the data, as well as ANOVA test and residual plots for some of the fitted Horton equations in comparison to the Green-Ampt equation.

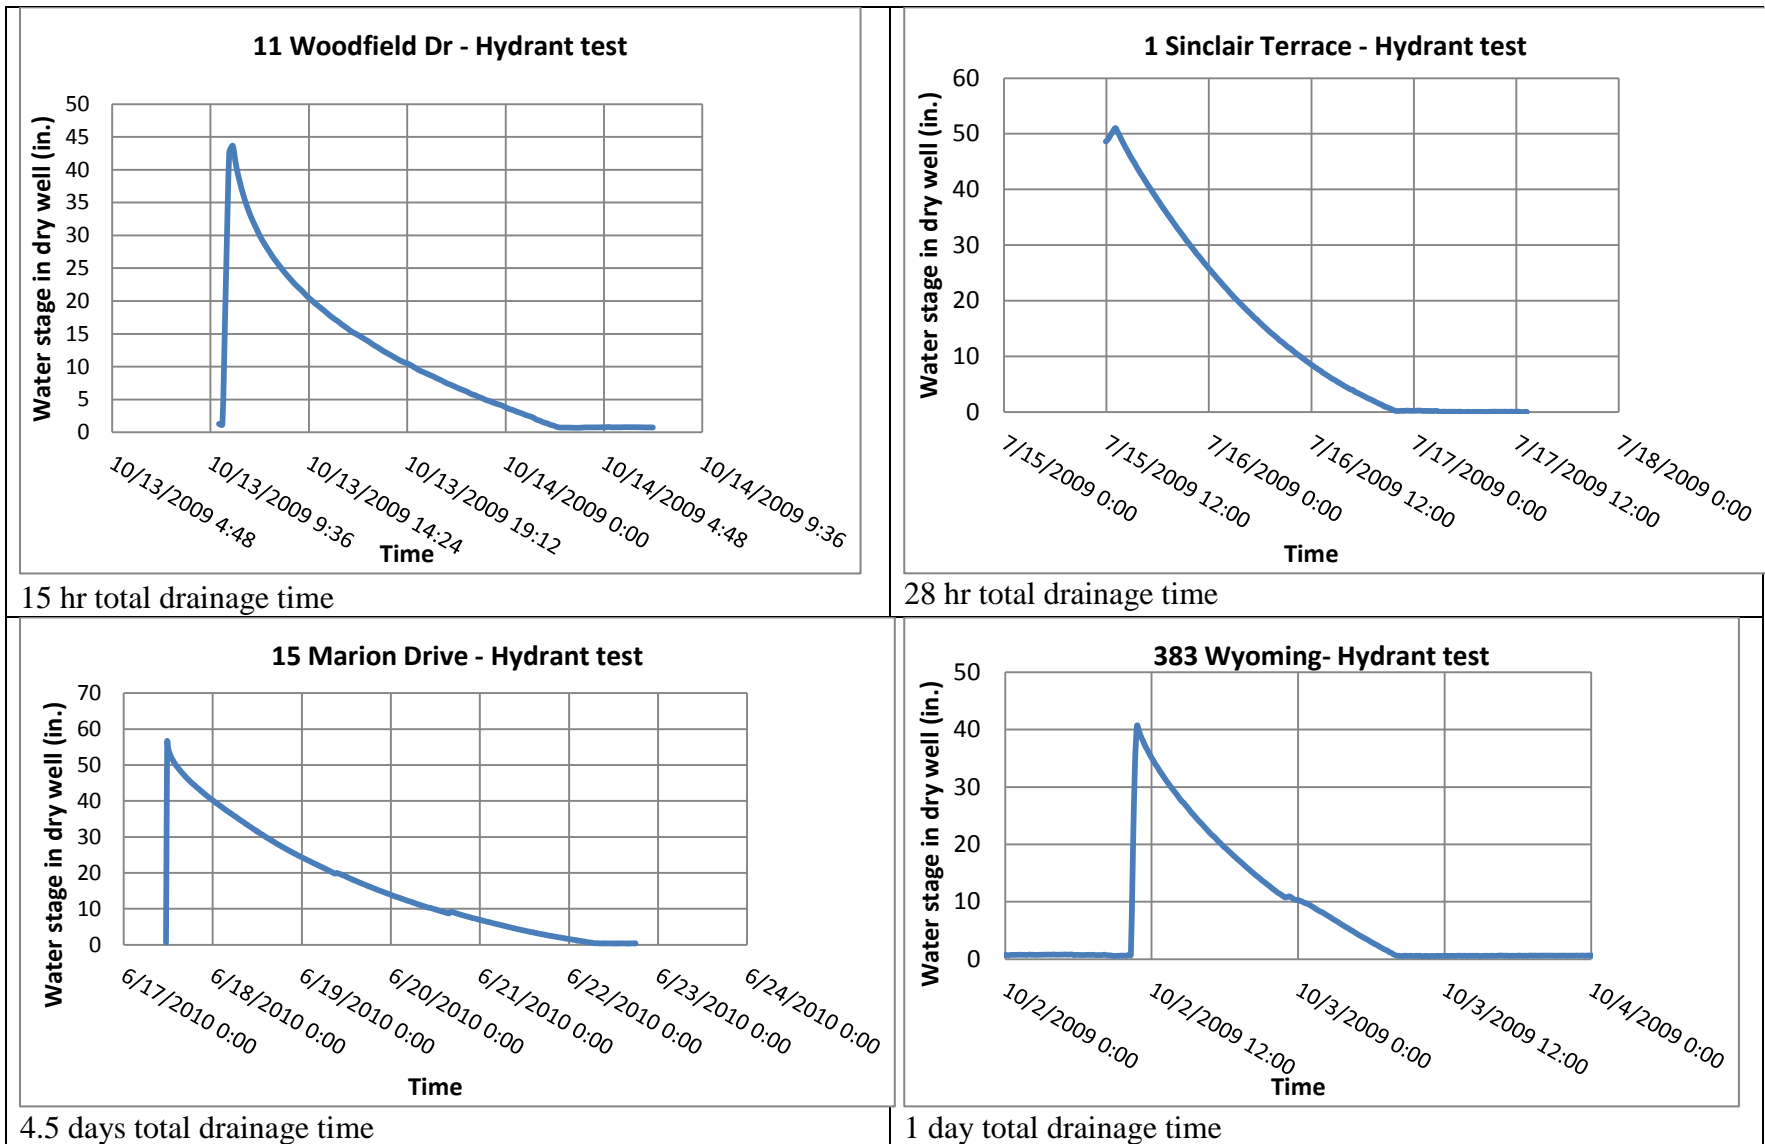
Figure 4.15. Hydrant water test infiltration plots. (1 in = 25.4 mm)

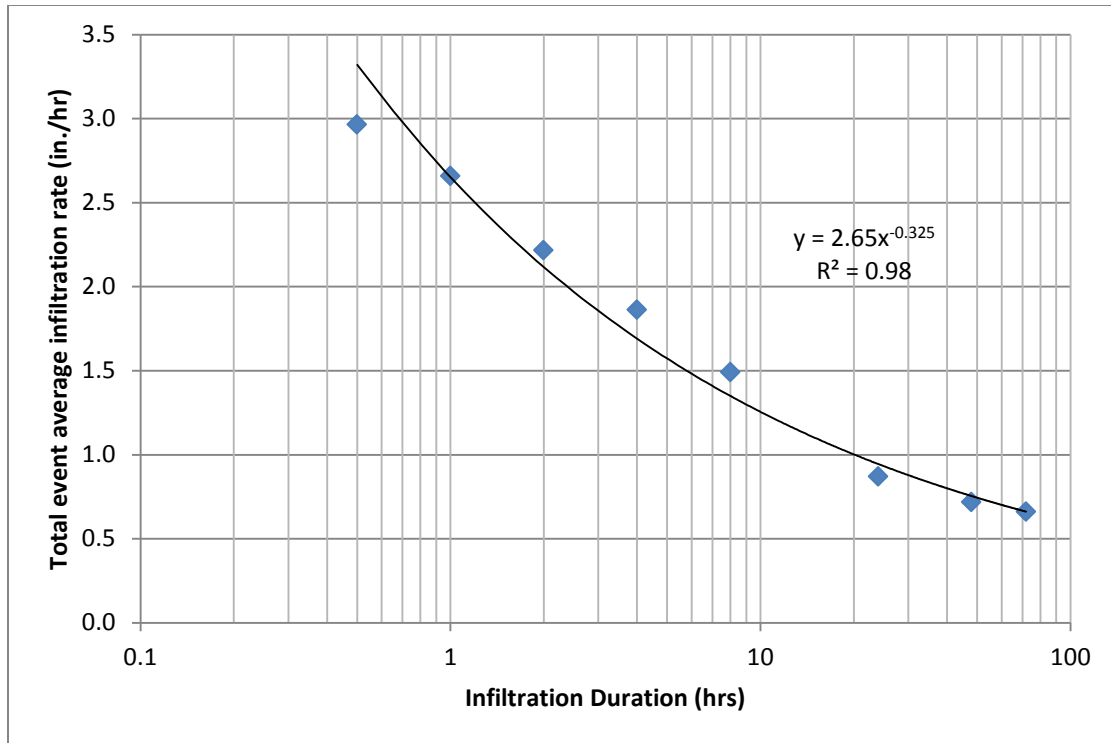
Figure 4.19. Infiltration rates averaged over event durations for C and D surface soils and well-drained A and B subsurface soils. (1 in/hr = 25.4 mm/hr)

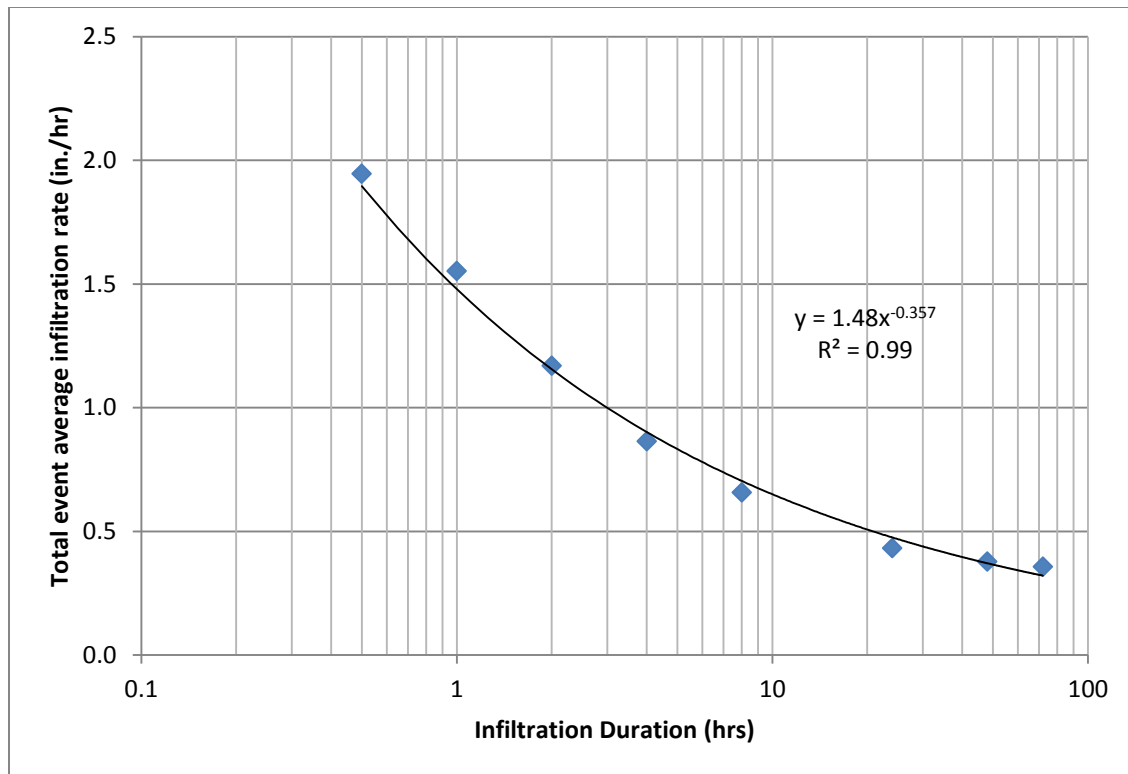
Figure 4.20. Infiltration rates averaged over event durations for C and D surface soils and poorly-drained A and B subsurface soils having extended standing water. (1 in/hr = 25.4 mm/hr)

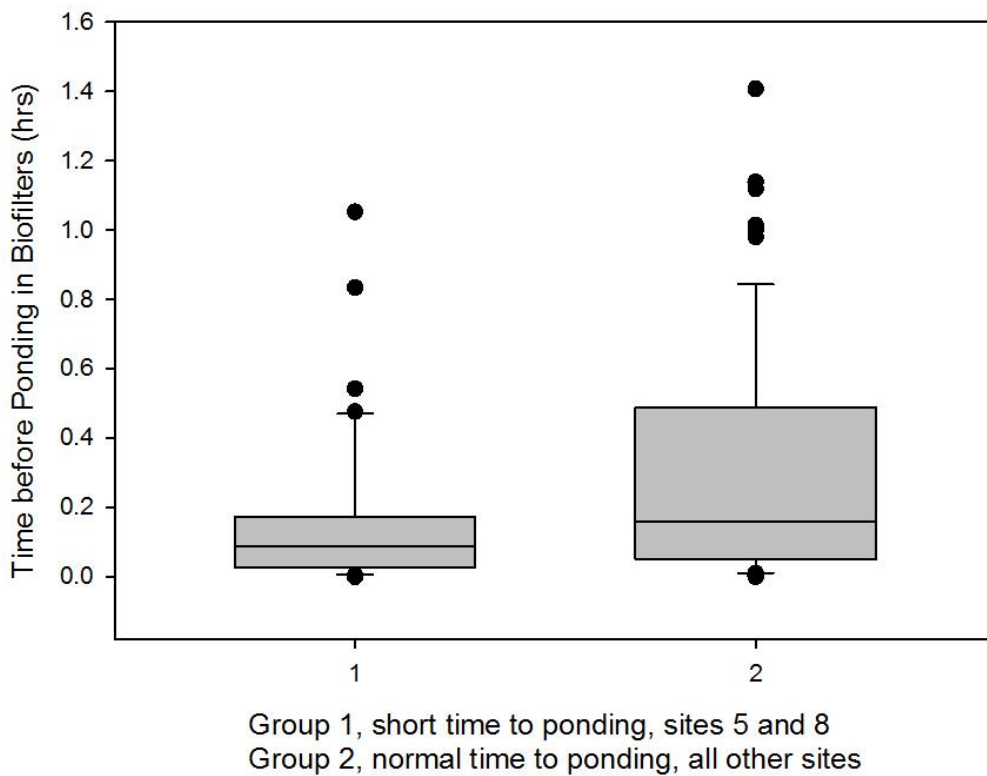
Figure 4.25. Short and Long Time to Ponding Groups at Monitored Biofilters

The following box and whisker plot and Mann-Whitney statistical test results summarize the time to ponding for these two significantly different groups of data. The biofilters at 1336 E 76th St and 1112 E 76th Terrace had the shortest ponding periods (about 5 minutes), and were also the two sites with the highest average infiltration rates (possibly the opposite of what would be expected, but may be due to other site characteristics). The other sites had average ponding times of about 10 minutes since the start of the observed runoff.

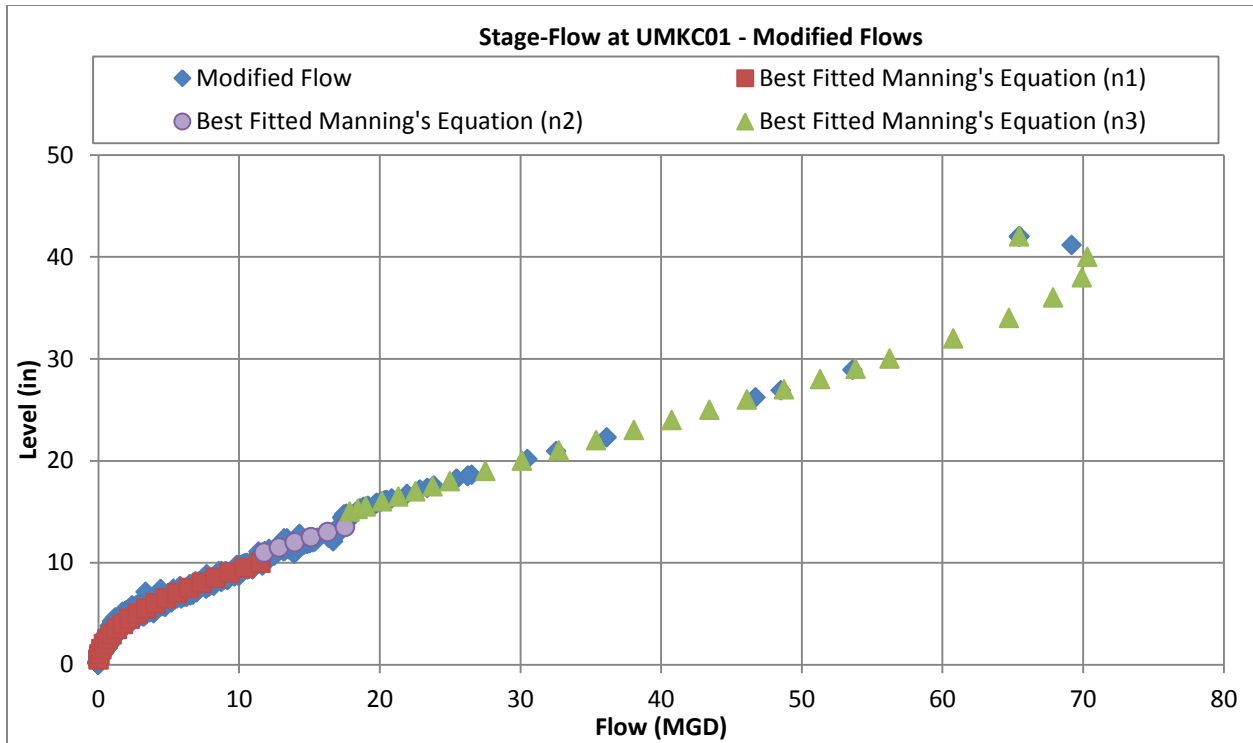
Figure 4.36. Modified Stage-discharge relationship at UMKC01

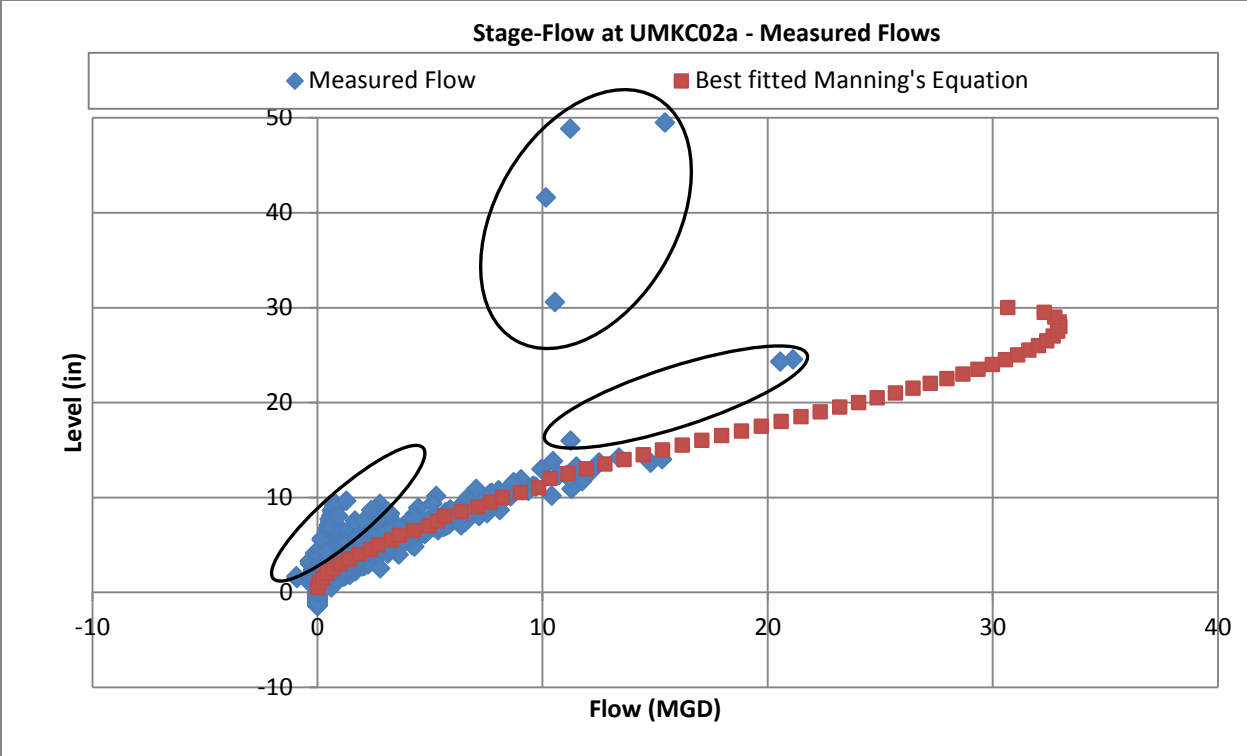
Figure 4.37. Stage-discharge relationship at UMKC02a for measured flows

Similarly, the stage-discharge relationships were plotted and studied for the observed data from the UMKC02a monitoring location (part of the control watershed area). Different Manning's  $n$  values were also fitted to the observed flows that varies with the stage values (ranging from  $n = 0.012$  to  $0.019$ ). As shown in Figure 4.37, the measured flow data are more scattered at UMKC02a than at UMKC01, requiring about 80% of the data being modified using the calibrated Manning's equation. Figure 4.38 shows the final set of observations. Figure 4.37 represents stage-discharge conditions at UMKC02a for the measured flows.

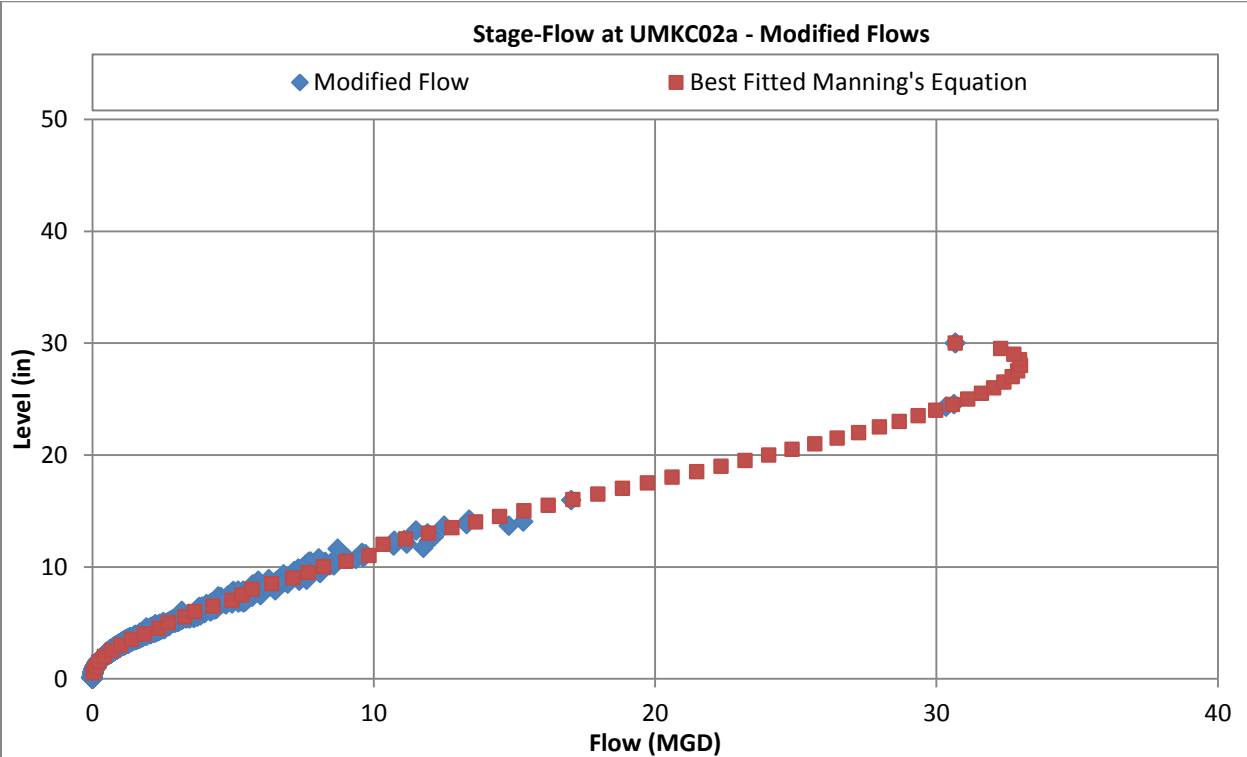
Figure 4.38. Modified Stage-discharge relationship at UMKC02a
