ASSESSMENT OF INTEGRATED GREEN INFRASTRUCTURE-BASED  
STORMWATER CONTROLS IN SMALL TO LARGE SCALE DEVELOPED  
URBAN WATERSHEDS

A DISSERTATION

Submitted in partial fulfillment of the requirements  
for the degree of Doctor of Philosophy  
in the Department of Civil, Construction, and Environmental Engineering  
in the Graduate School of  
The University of Alabama

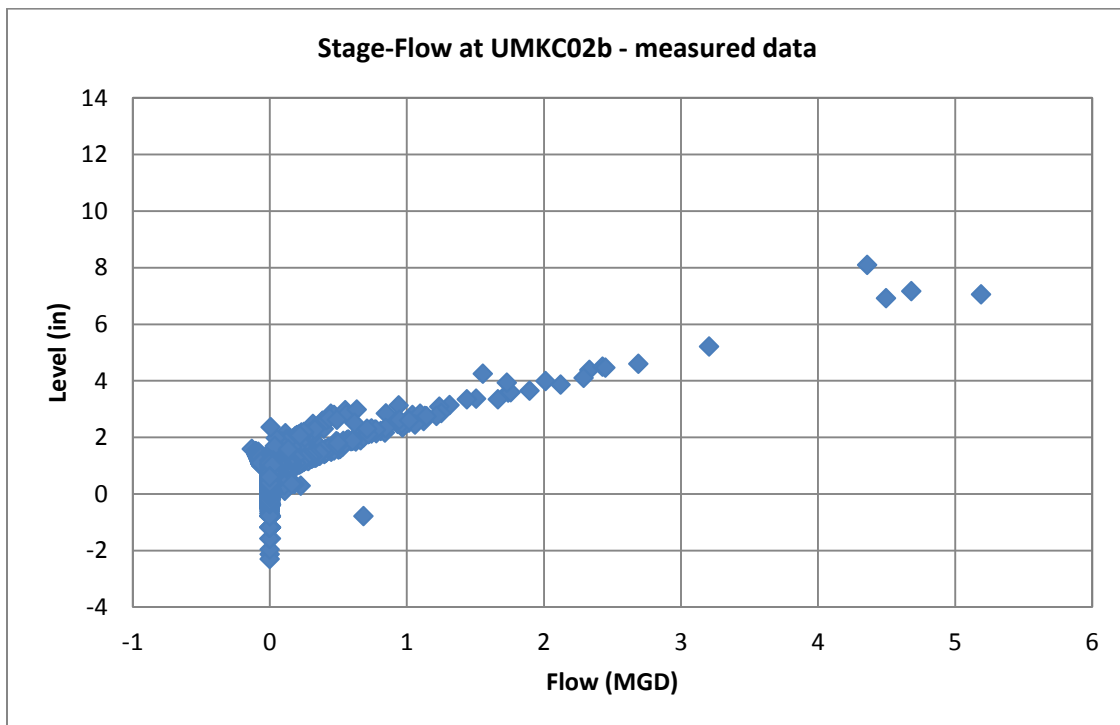
Figure 4.39. Stage-discharge relationship at UMKC02b for measured flows.

Figures 4.39 and 4.40 are similar stage-discharge plots for the two other control area monitoring locations: UMKC02b and UMKC03. As seen on both of these plots, there is a great deal of uncertainty in the plots and all stage values observed were quite small (most less than about 4 inches at UMKC2b in a 24 inch pipe and a maximum stage of about 2.5 inches at UMKC03 in a 30 inch pipe). It was not possible to perform a suitable Manning's n calibration with these data. It is very challenging to measure flows accurately at low stages, especially when the pipes are relatively large.

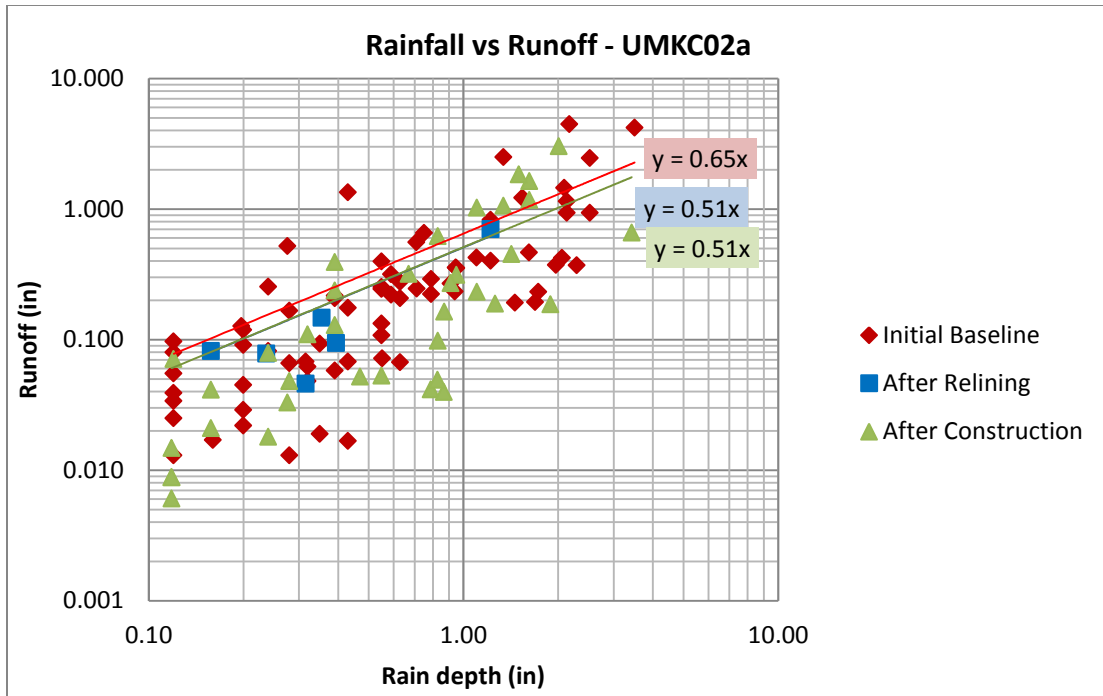
Figure 4.45. Scatterplot of monitored rain vs. runoff conditions at UMKC02a control location for different monitoring periods.

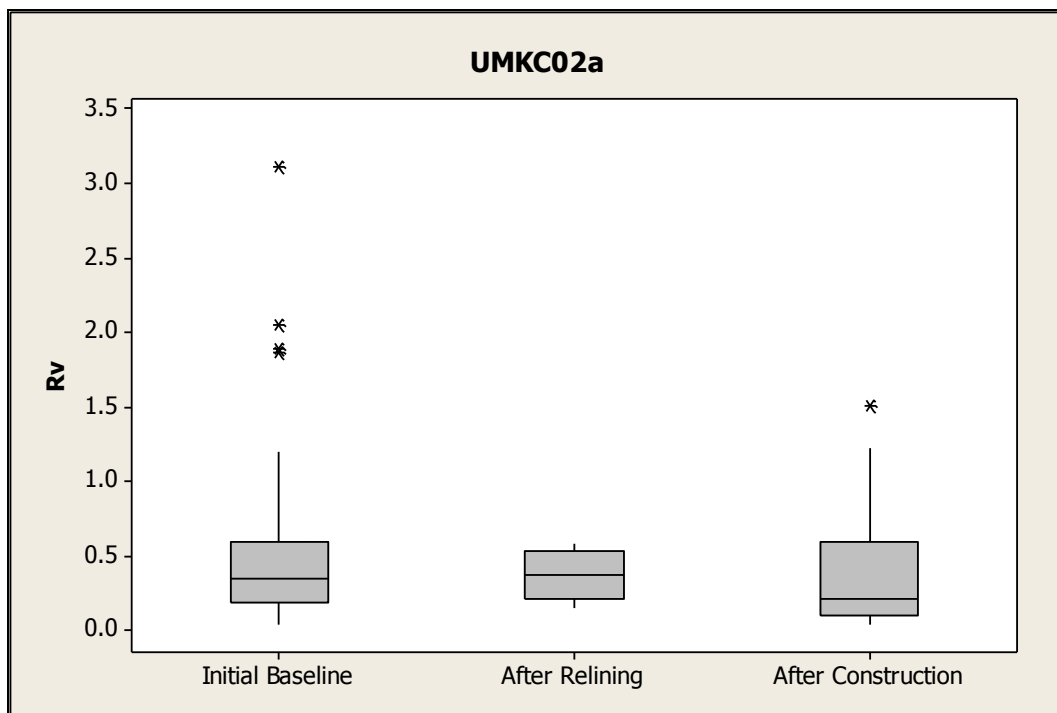
Figure 4.46. Box and whisker plot of monitored  $R_v$  values at UMKC02a control area for different monitoring phases (this area was not re-lined, but this plot compares the rain and runoff conditions during these time periods that had separate activities in the parallel UMKC01 test area).

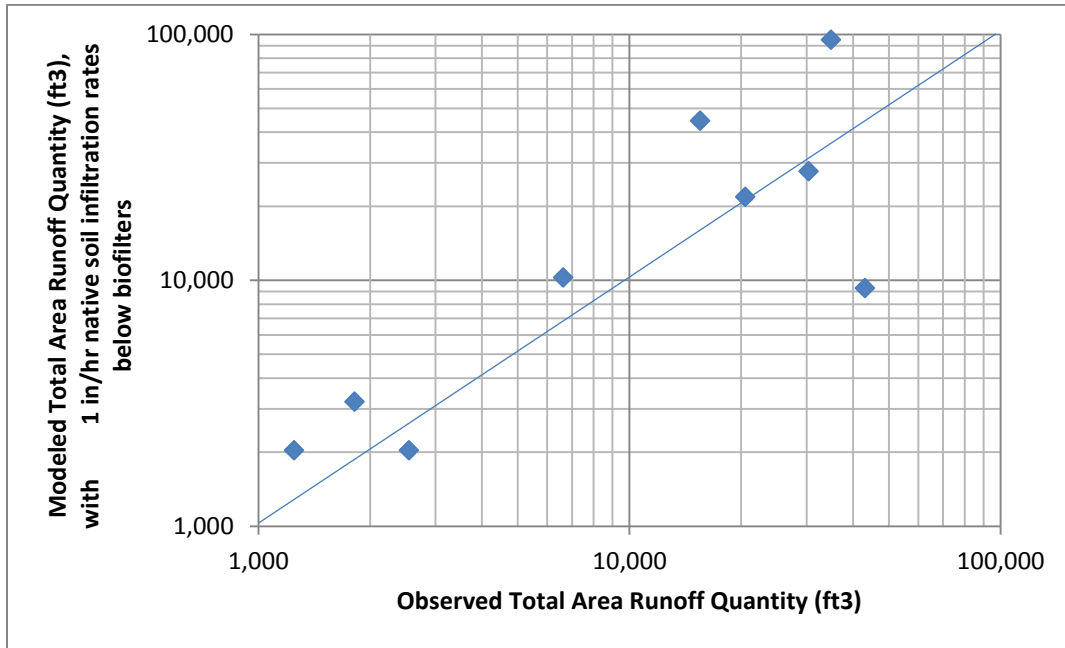
Figure 4.69. Observed and calculated flows for Kansas City, after biofilter construction.

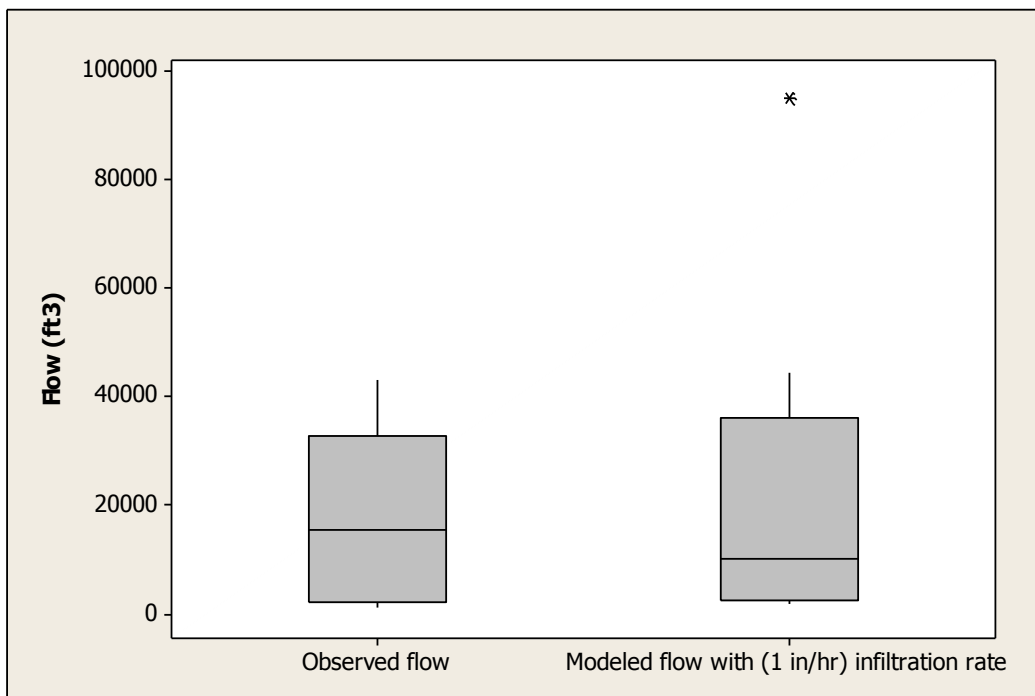
Figure 4.70. Box plot of observed and calculated flows for Kansas City, after biofilter construction.

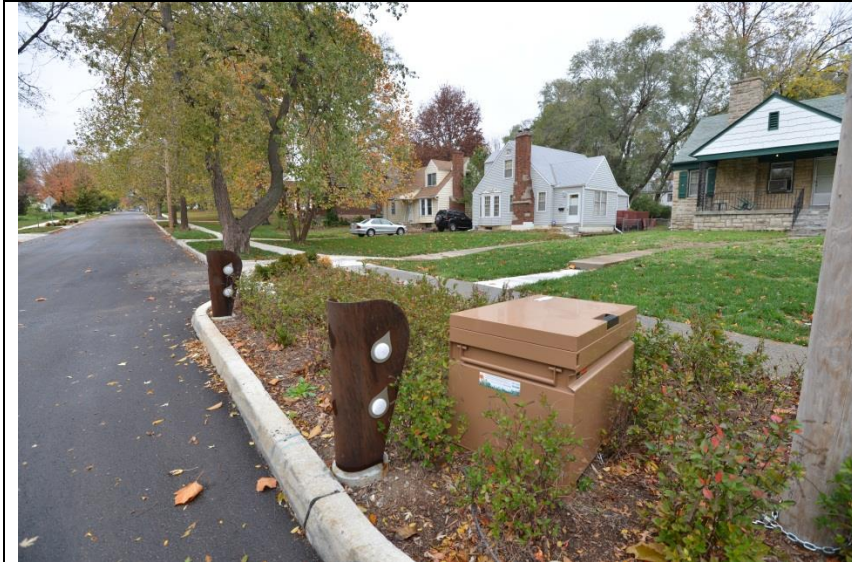
**1324 E 76<sup>th</sup> St #1 (sheet 305 for as-built details); no underdrains**

Only received flows from W along E 76<sup>th</sup> St (from driveway up)

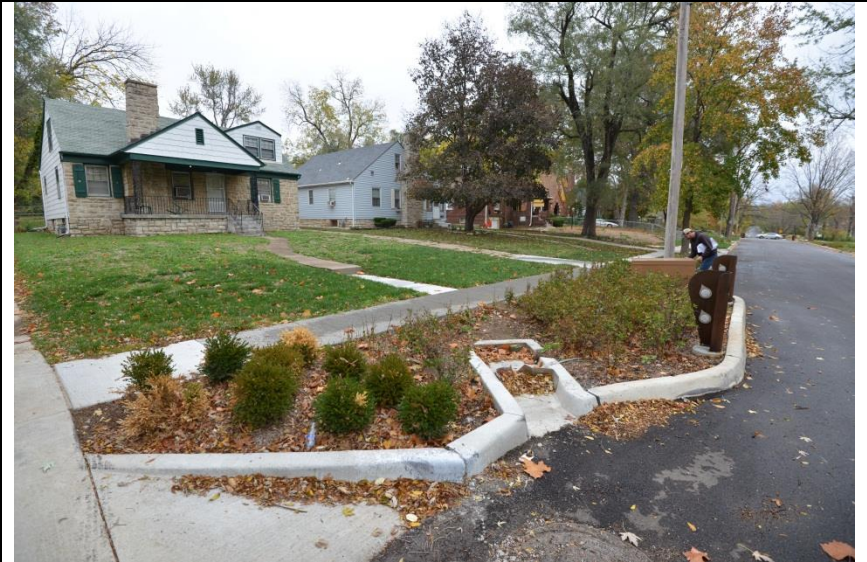
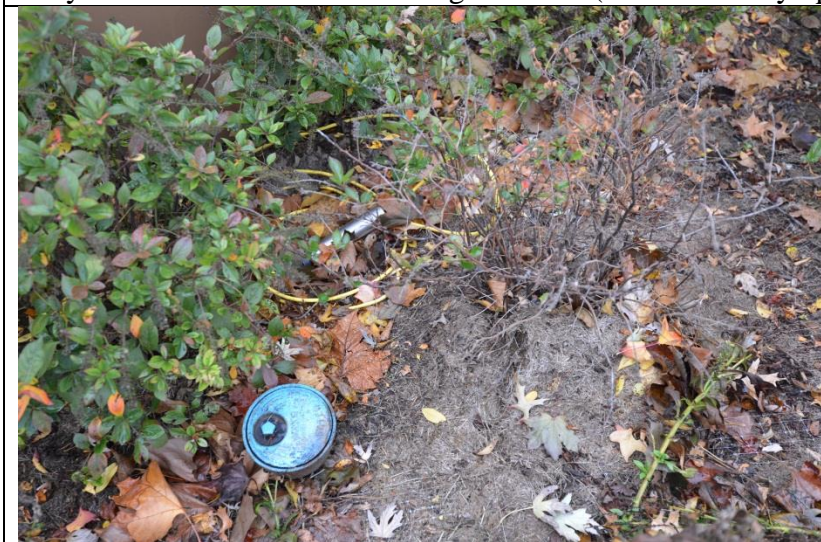
2 samplers and 2 level recorders (inlet and bottom of garden)

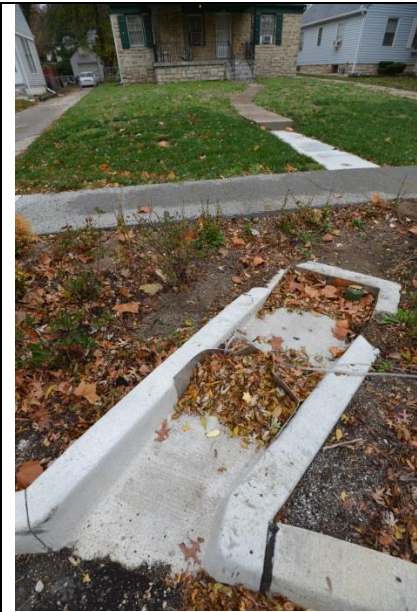
Leaves washed into inlet

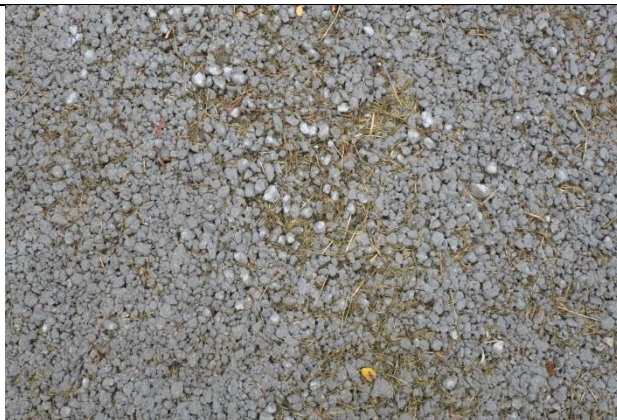
Porous concrete alongside of rain garden collects yard runoff to garden

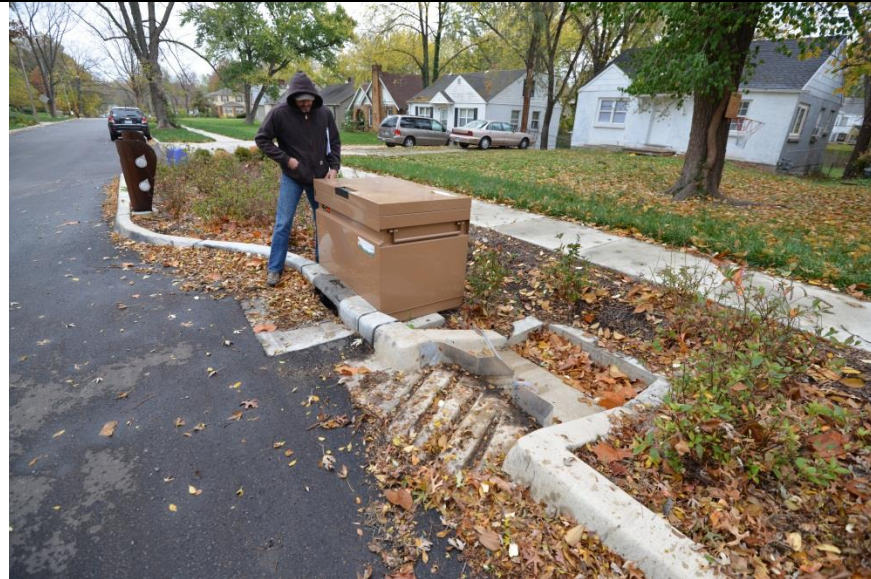
**1325 E 76<sup>th</sup> St #2 (sheet 305 for as-built details); no underdrains**

Drains from street centerline to far side of sidewalk to centerline of Troost

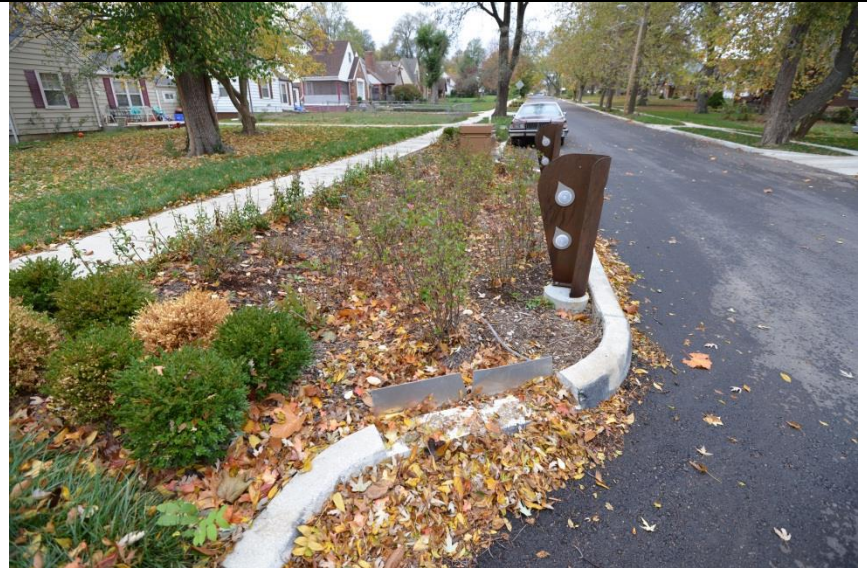
Looking upgradient towards Troost (most of lawns and homes slope south away from this location)

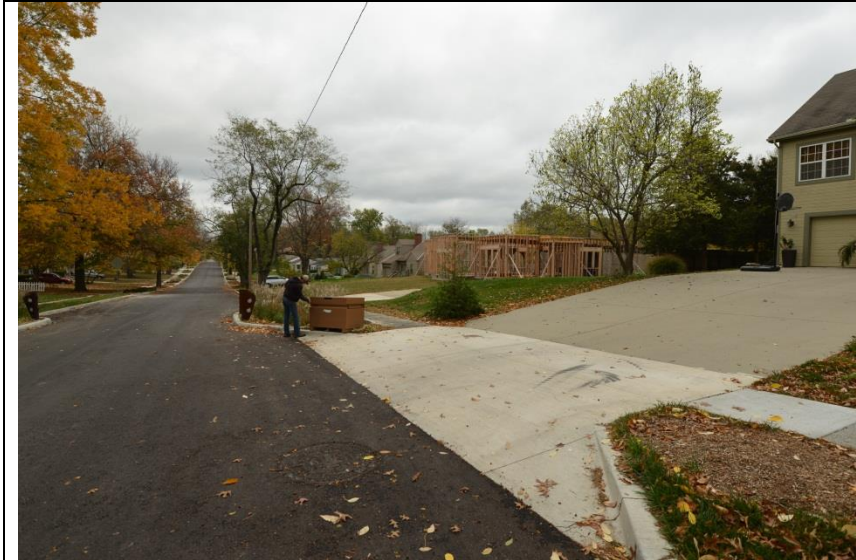
**1419 E 76<sup>th</sup> Terrace #3 (sheet 207 for as-built details); no underdrains; reported to not drain well**

Downgradient (towards east)

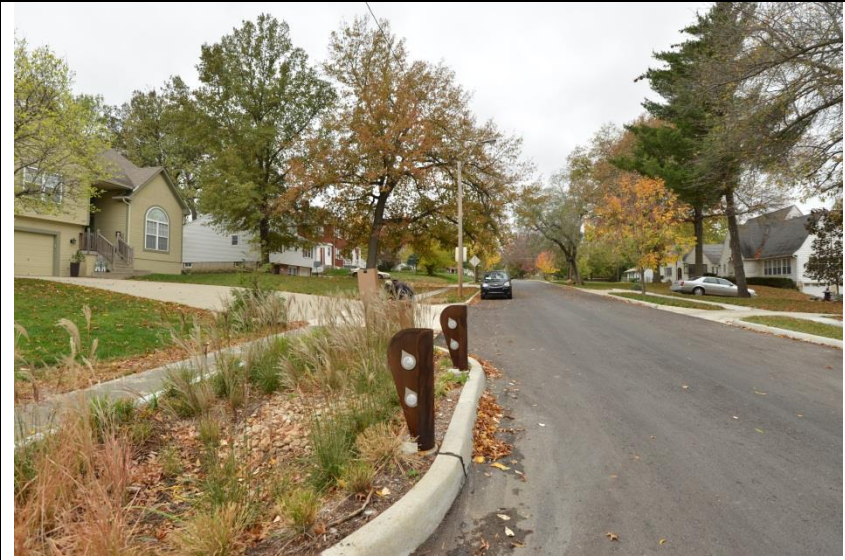
Upgradient (towards west to Lydia); drains from center of lots to Lydia

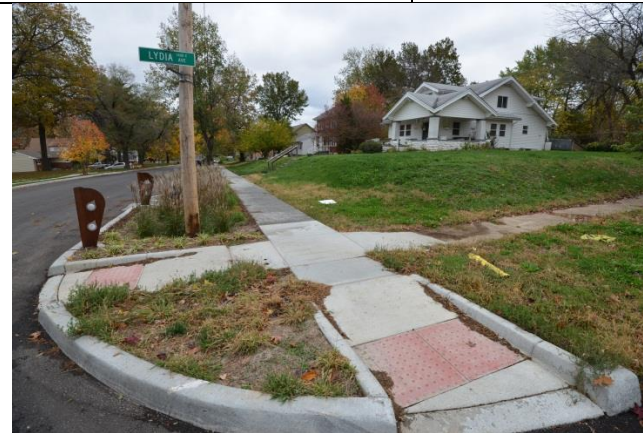
Corner of Lydia to E 76<sup>th</sup> Terrace (upper end of drainage)

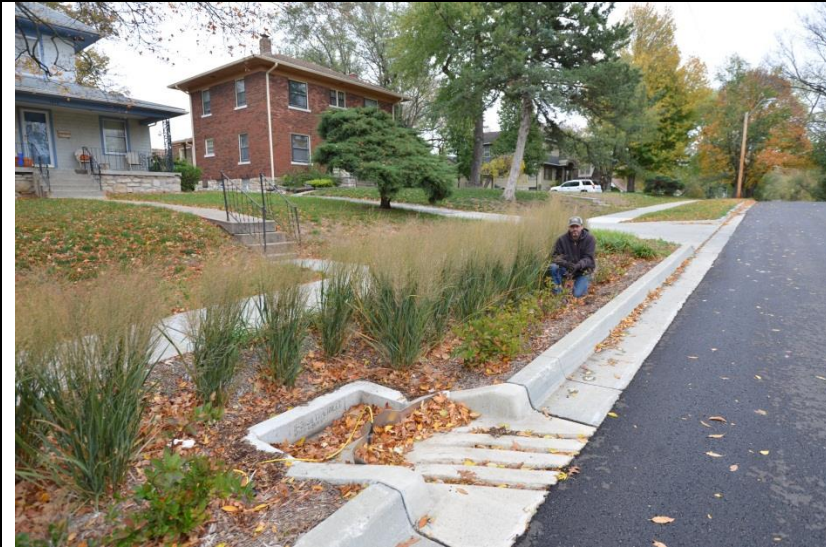
**1612 E 76<sup>th</sup> St. #4 (sheet 307 for as-built details); no underdrains**

No samplers but two level recorders (inlet and bottom of garden) towards East (upgradient)

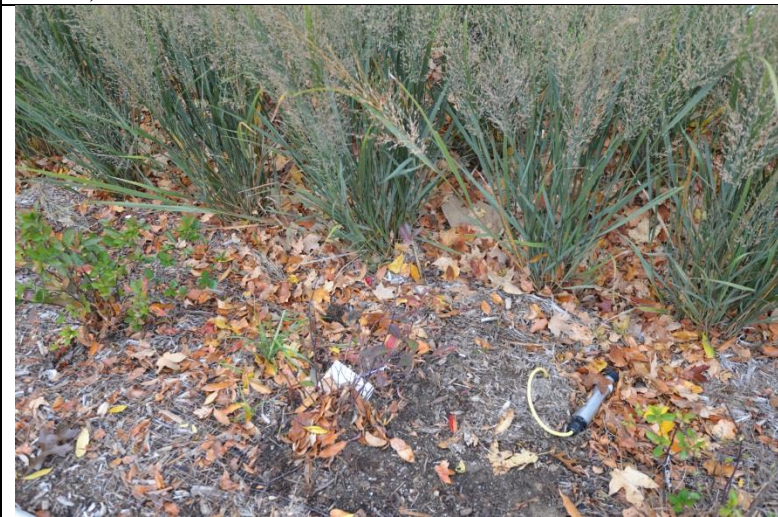
Level sensor recorder in bottom of rain garden

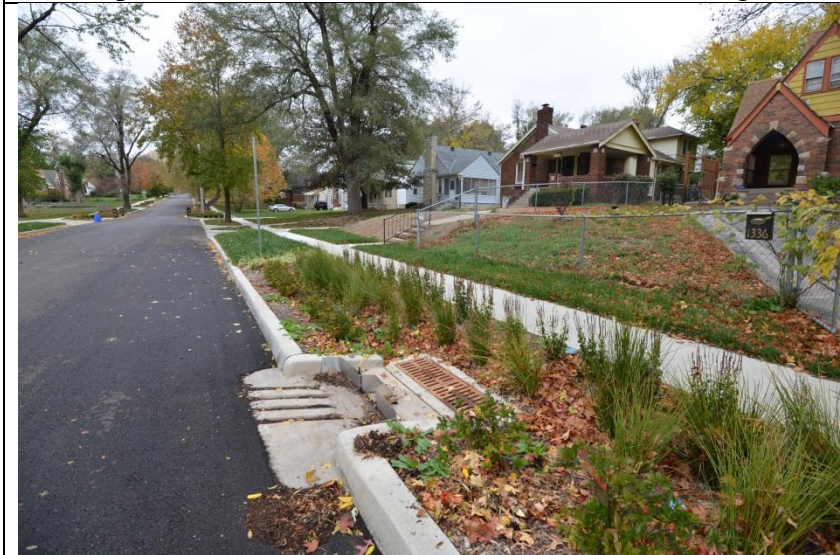
No samplers, 2 level recorders (inlet and bottom of rain garden)

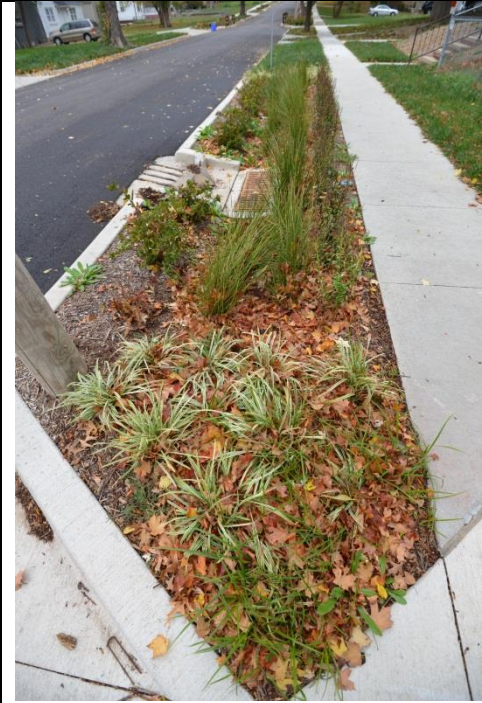
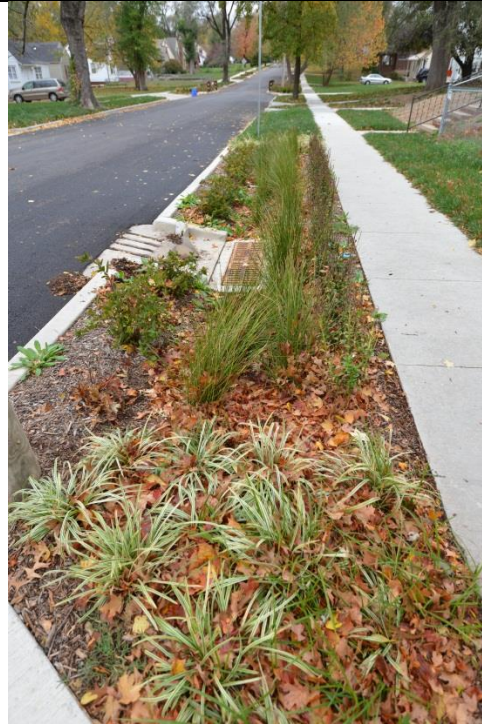
Upgradient from rain garden

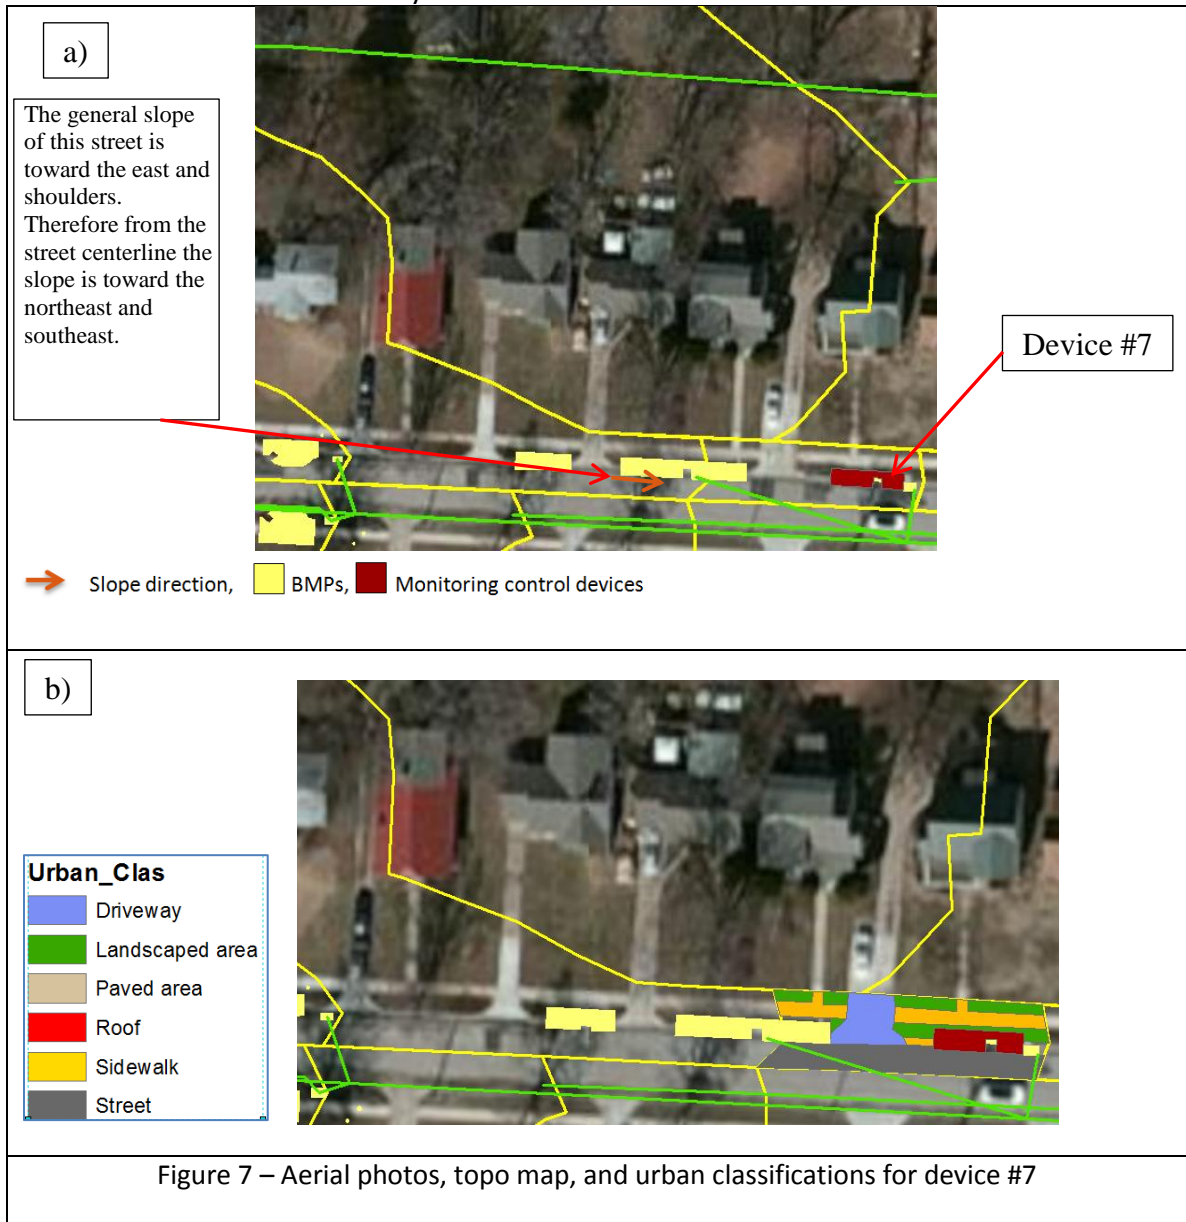
**7. Shallow Bioretention Device w/ Smart Drain - 1140 E 76th Terr.**

Location	Urban Classification	Area (ac)	Note/Assumption
Figure 7-b	Driveway	0.00482	
	Landscaped area	0.00318	
	Sidewalk	0.00067	
	Street	0.01596	
Total area (ac)		0.02462

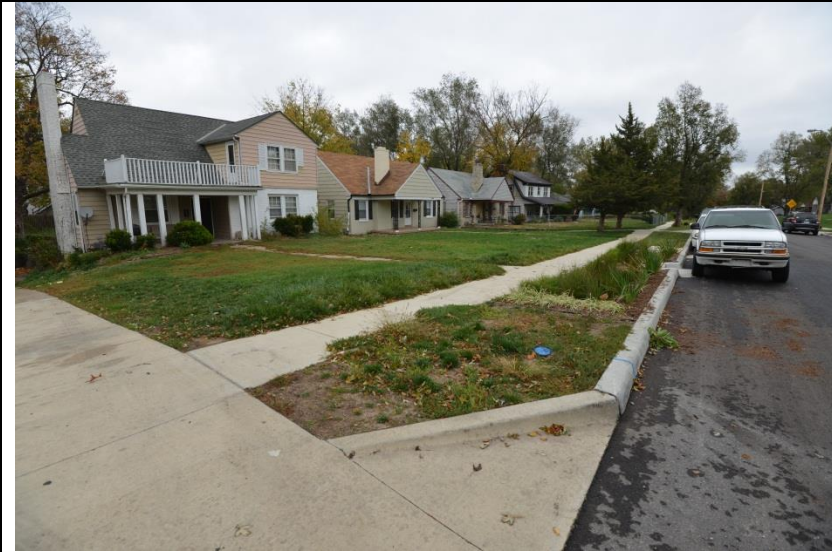
Towards E showing sloping driveway from rain garden; only half of street and a bit of yard to system (near top of street slope)

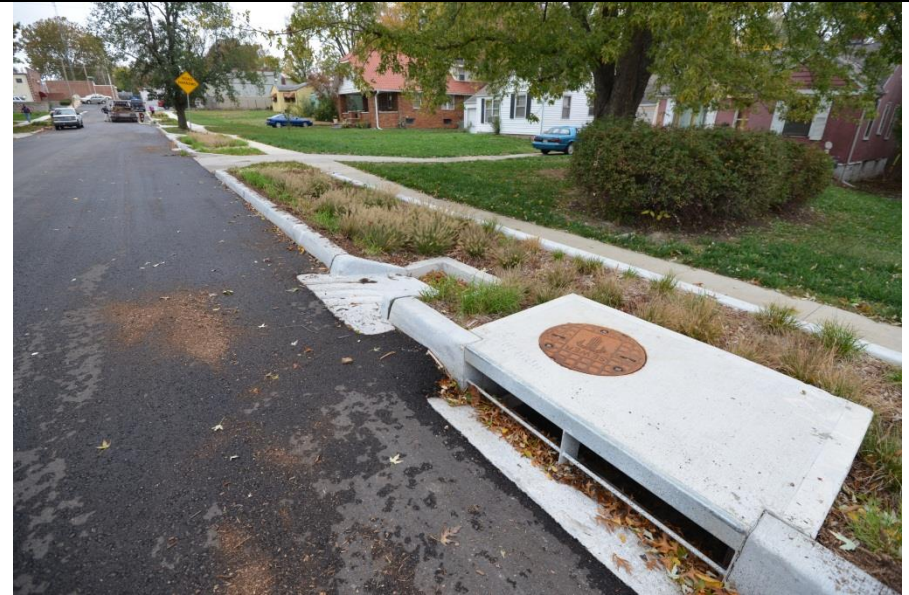
Very small drainage area; large inlet right below rain garden

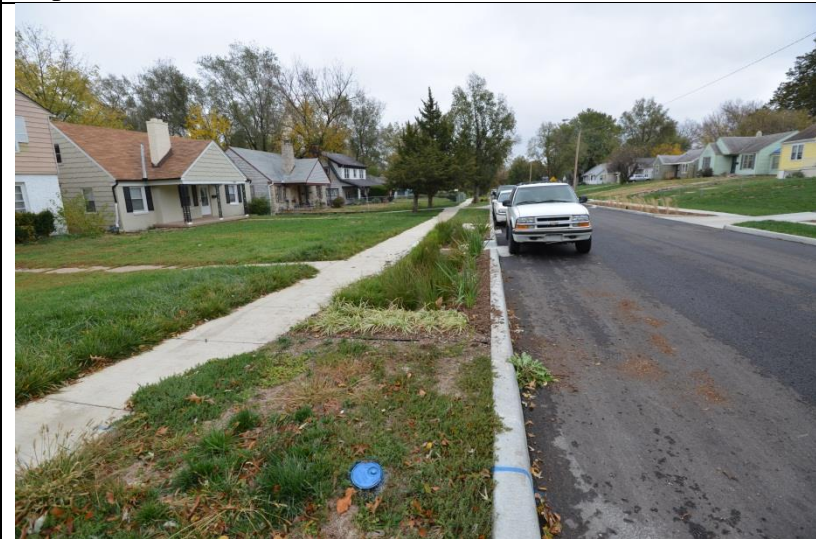
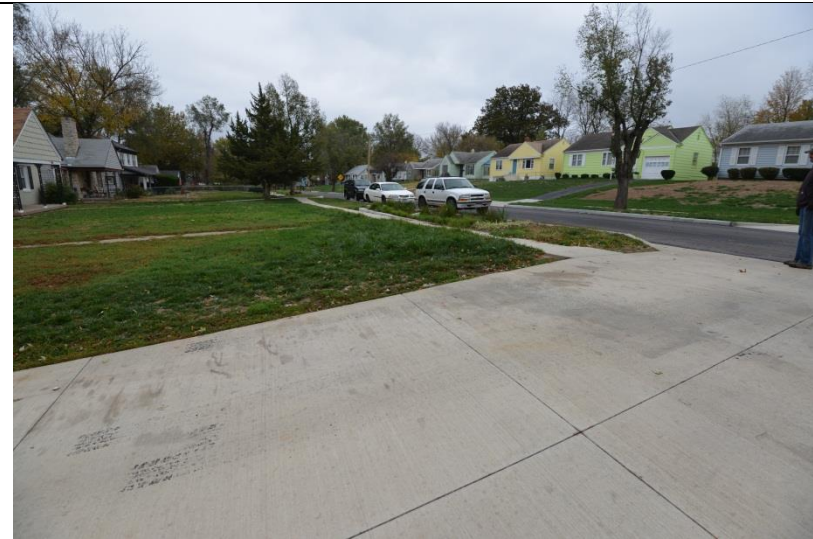
Yard slopes away from rain garden; sidewalk edge to street center

Driveway slopes away from rain garden towards yard inlets

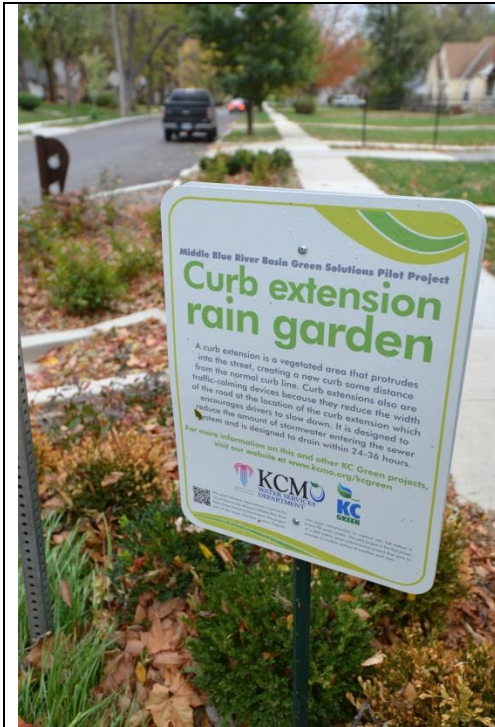
Upgradient rain garden and signage

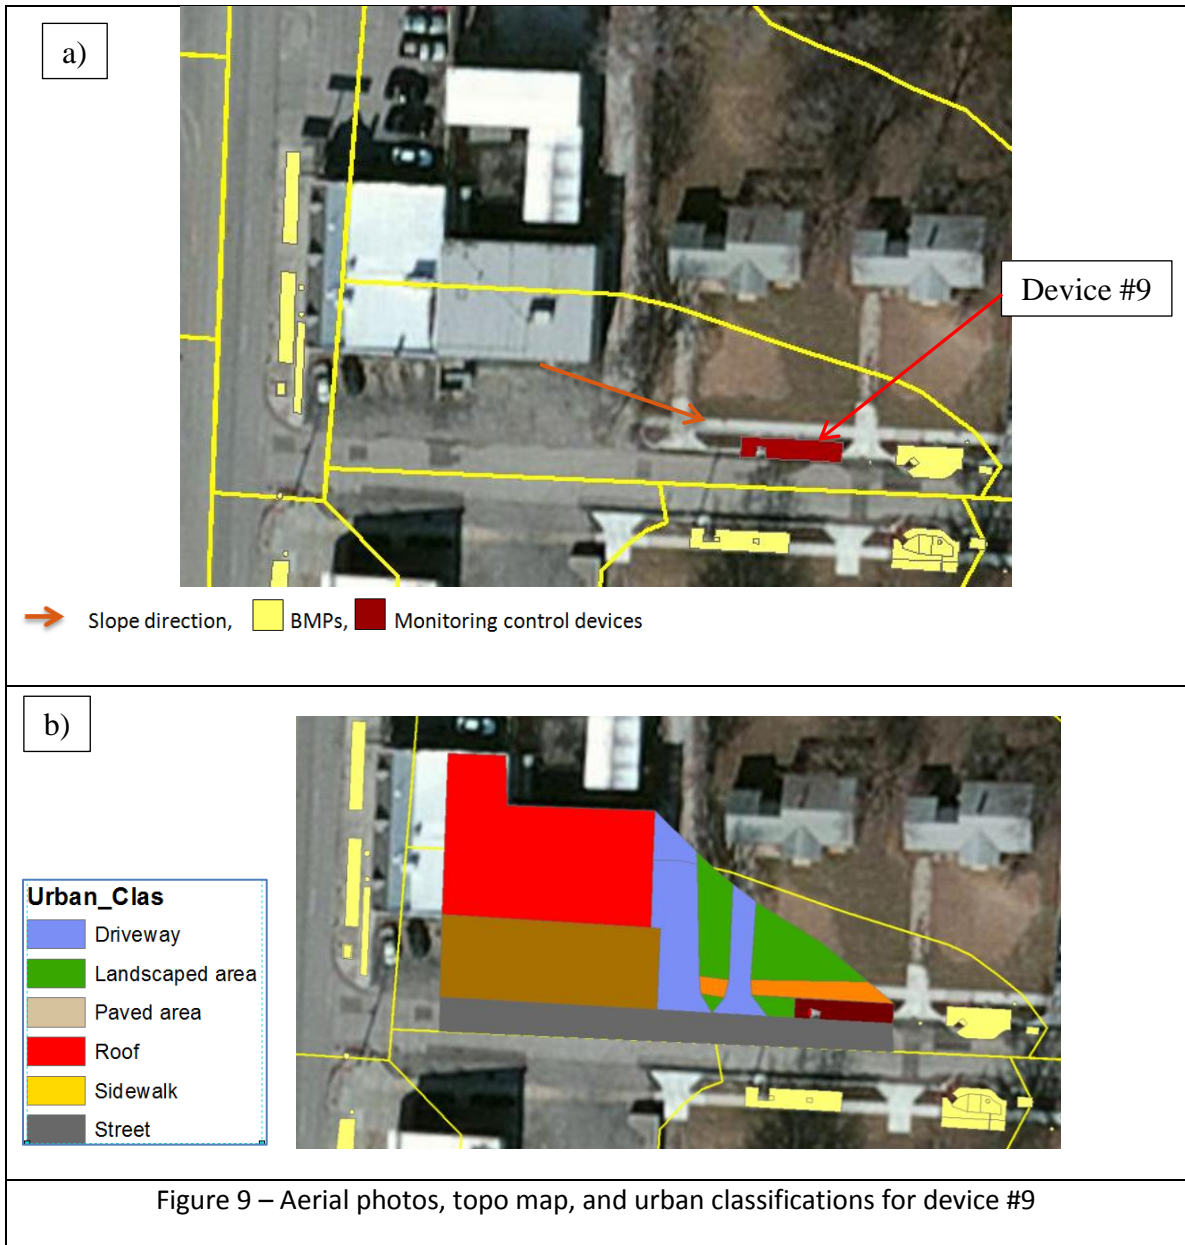
**9. Cascade - 1112 E 76th Terr.**

Location	Urban Classification	Area (ac)	Note/Assumption
Figure 9-b	Driveway	0.0392	There is no overflow from upstream, as shown in Figure 9-b.
	Landscaped area	0.0337	
	Parking lot	0.0639	
	Roof	0.0958	
	Sidewalk	0.0101	
	Street	0.0505	
Total area (ac)		0.2931

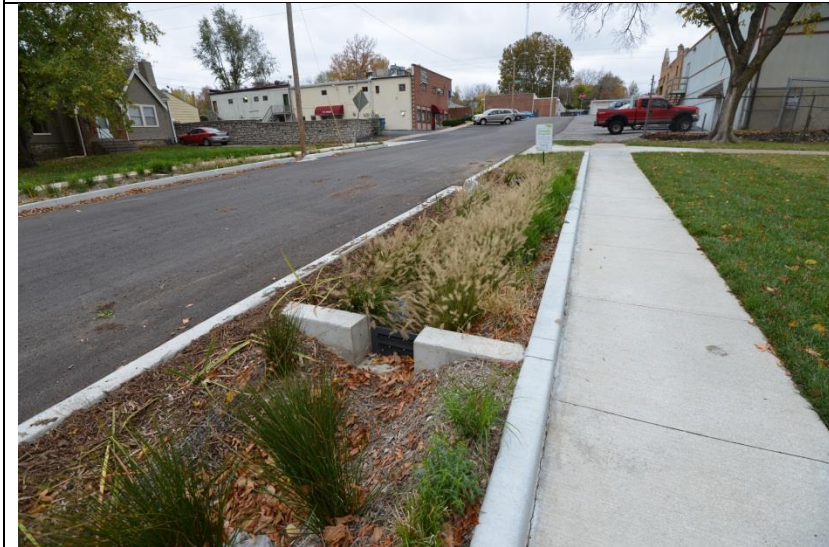
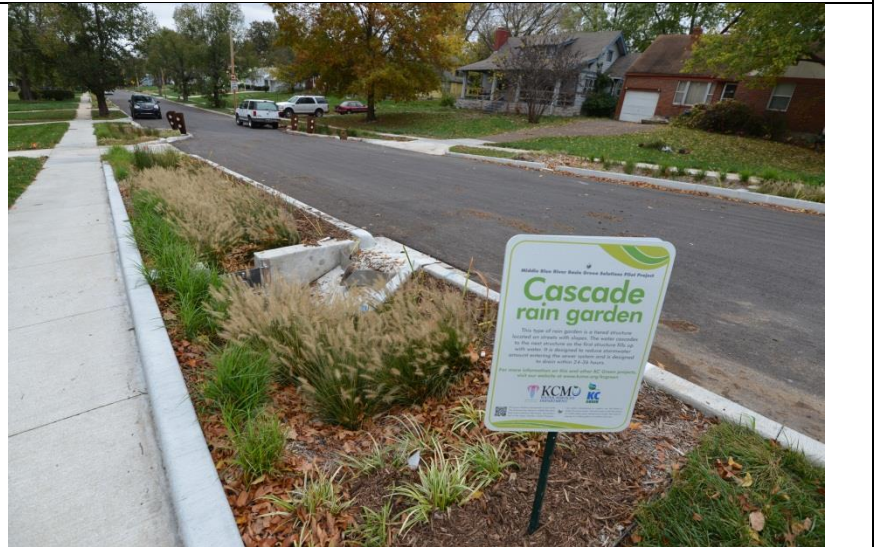
W towards Troost and two businesses that drain to this device

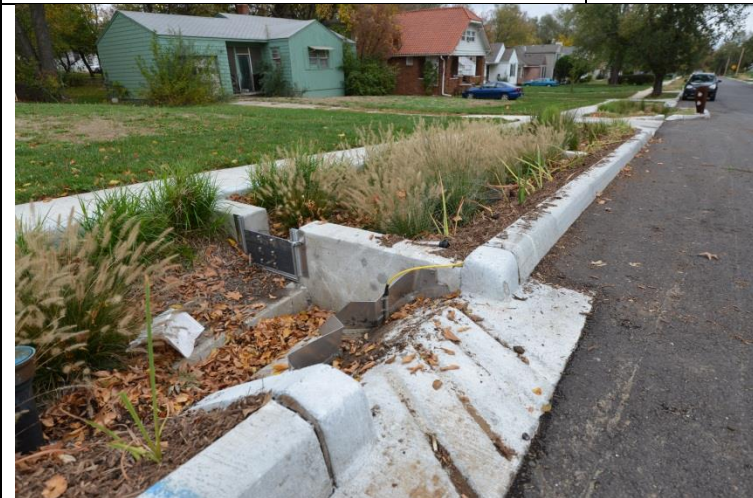
Towards cascade from next downgradient rain garden and drain inlet

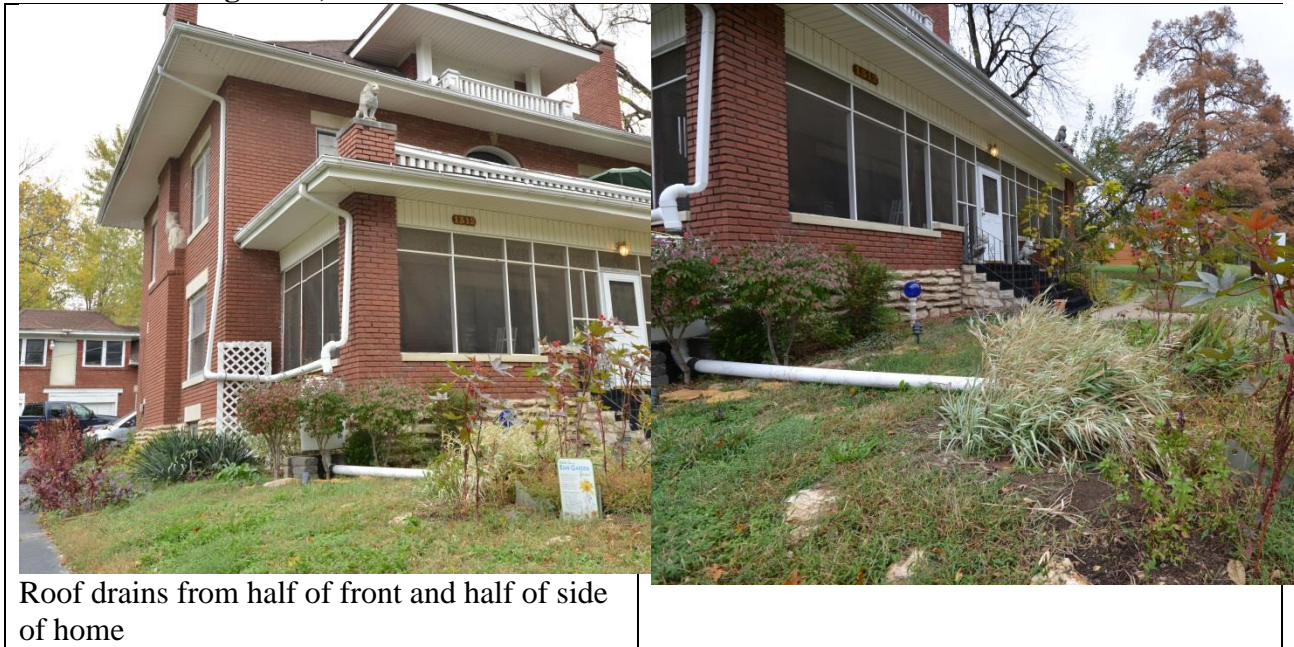
**1312 E 79<sup>th</sup> St #10; Mrs. Thomas Rain Garden (no details; two level recorders, inlet and bottom of rain garden)**
