Site Diary Campus Drive Relocation Project

Presented to: Dr. Pitt Construction Site Erosion Control

August 9, 2007

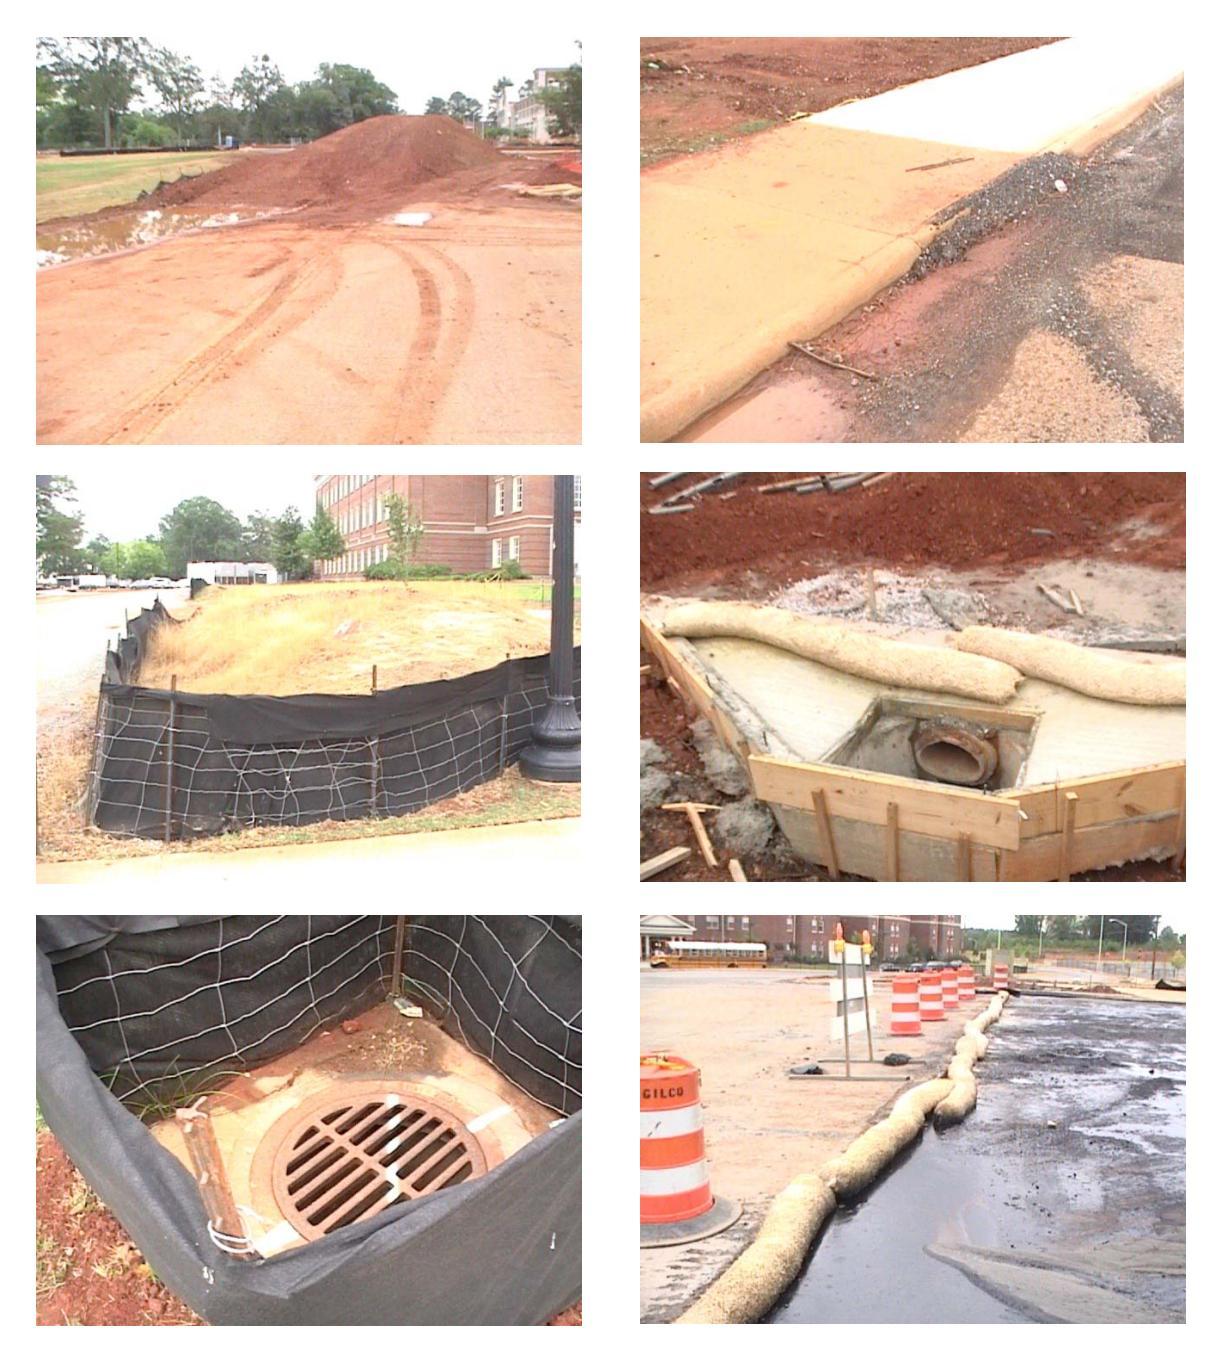
Figure 1: June 19, 2007 Photos

These photos are taken right after the class meeting on June 19. There are several stock piles causing the erosion on the road after the storm event due to the inappropriate erosion control. The site is just started grubbing and bare soils are seen on the surface. The site is protected by the silt fence and wattles are installed for the inlets.

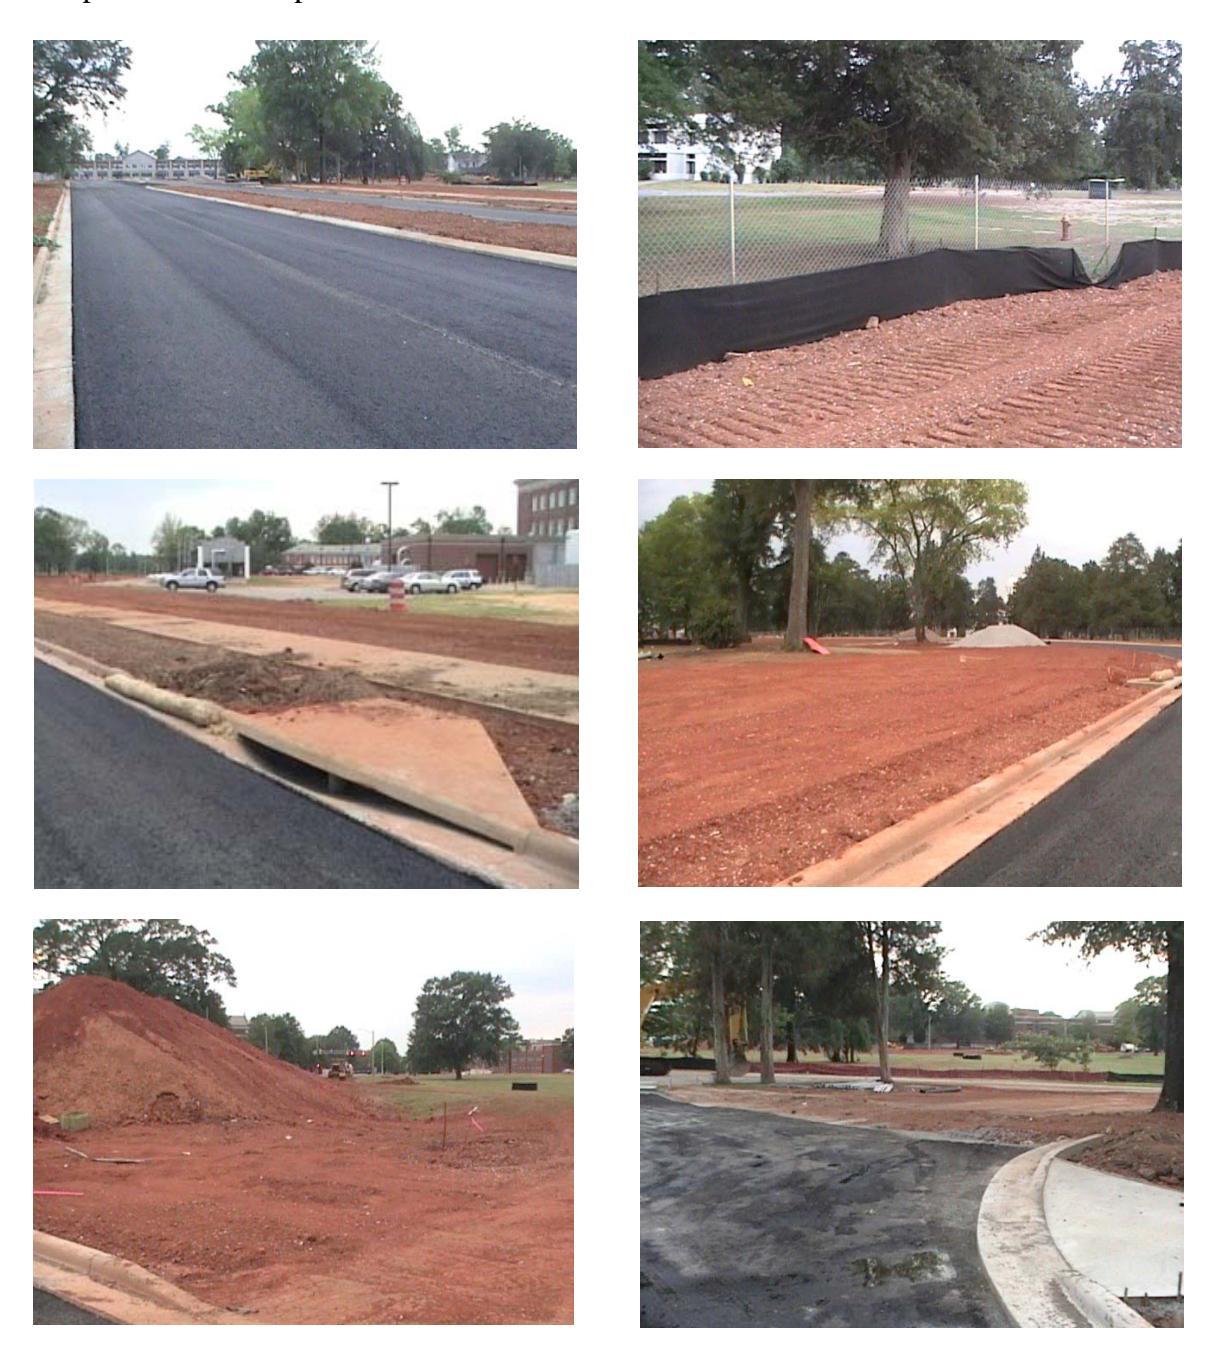
Figure 2: June 28, 2007 Photos

These photos are taken on June 28. The first phase of the construction is almost completed and there are bear soils on the side of newly installed roads. Also, the silt fence is equipped at all the side and down slope areas in order to prevent the soil erosion from the construction site to the existing properties. After the completion of the road, inlet protections including wattles are removed from the inlet. Second layer of the asphalt will be installed in a week. Stock piles in the yard in front of the Shelby Hall are not protected and expected to cause a sediment runoff after the storm event.

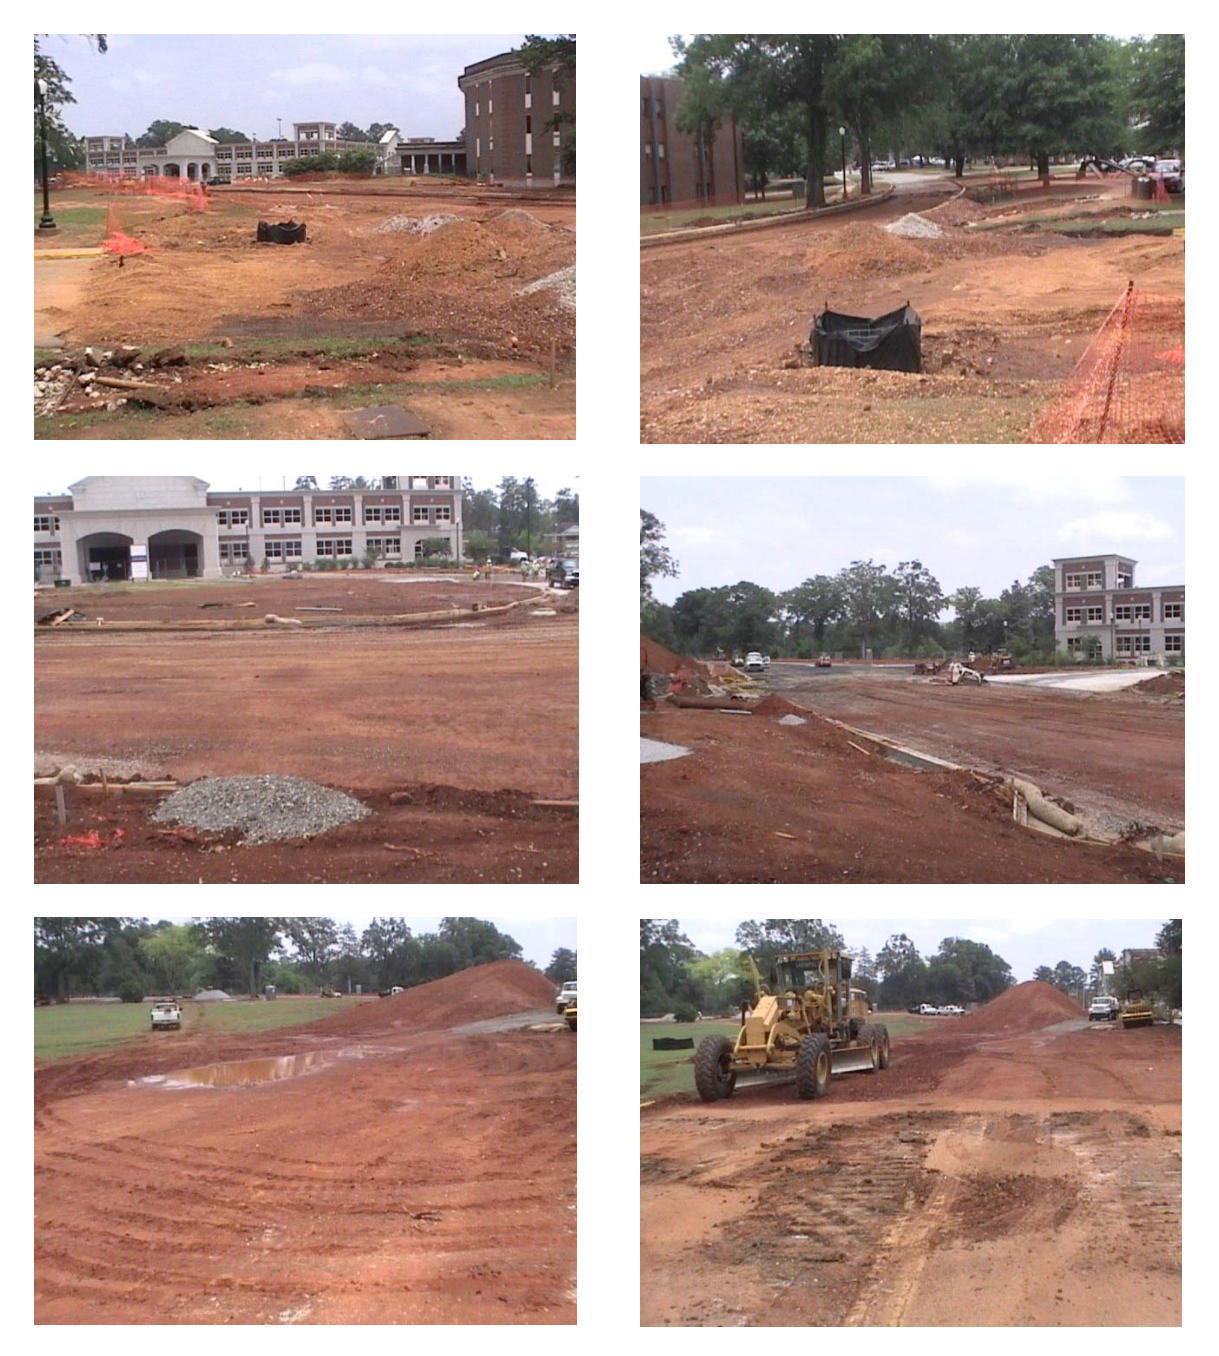
Figure 3: July 3, 2007 Photos

These photos are taken on July 3 after the storm event. Due to the improper sediment control for the stock pile on the road at the construction site, large amount of sediments are runoff from the pile. Photos are describing the phase 2 improvement construction period and bear soils are seen on the surface. Inlets are protected by the silt fence and the wattle. Also, the site is surrounded by the biennial fence.

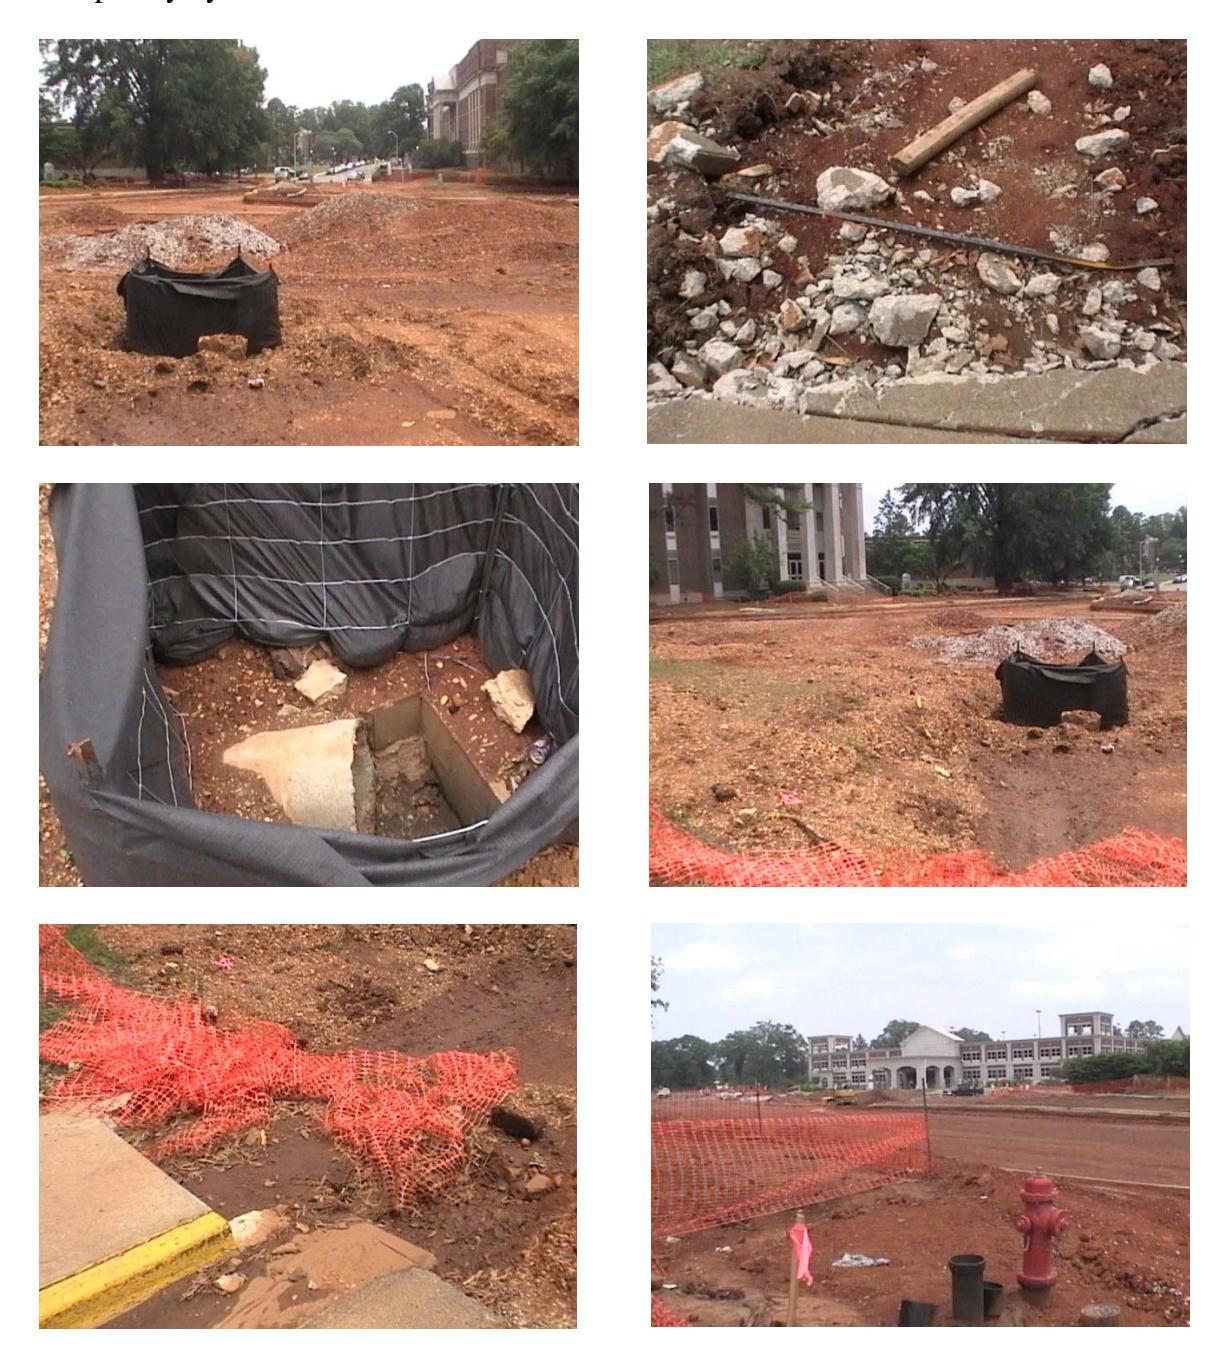
Figure 4: July 10, 2007 Photos

These photos are taken on July 10 after the storm event. Due to the storm, some fences are corrupted and it should be maintained immediately. Photos are taken during the period of the phase 2 improvement and bear soils are seen on the majorities of the surface. Inlets are protected by the silt fence and the wattle. The site is surrounded completely by the biennial fence and silt fences.

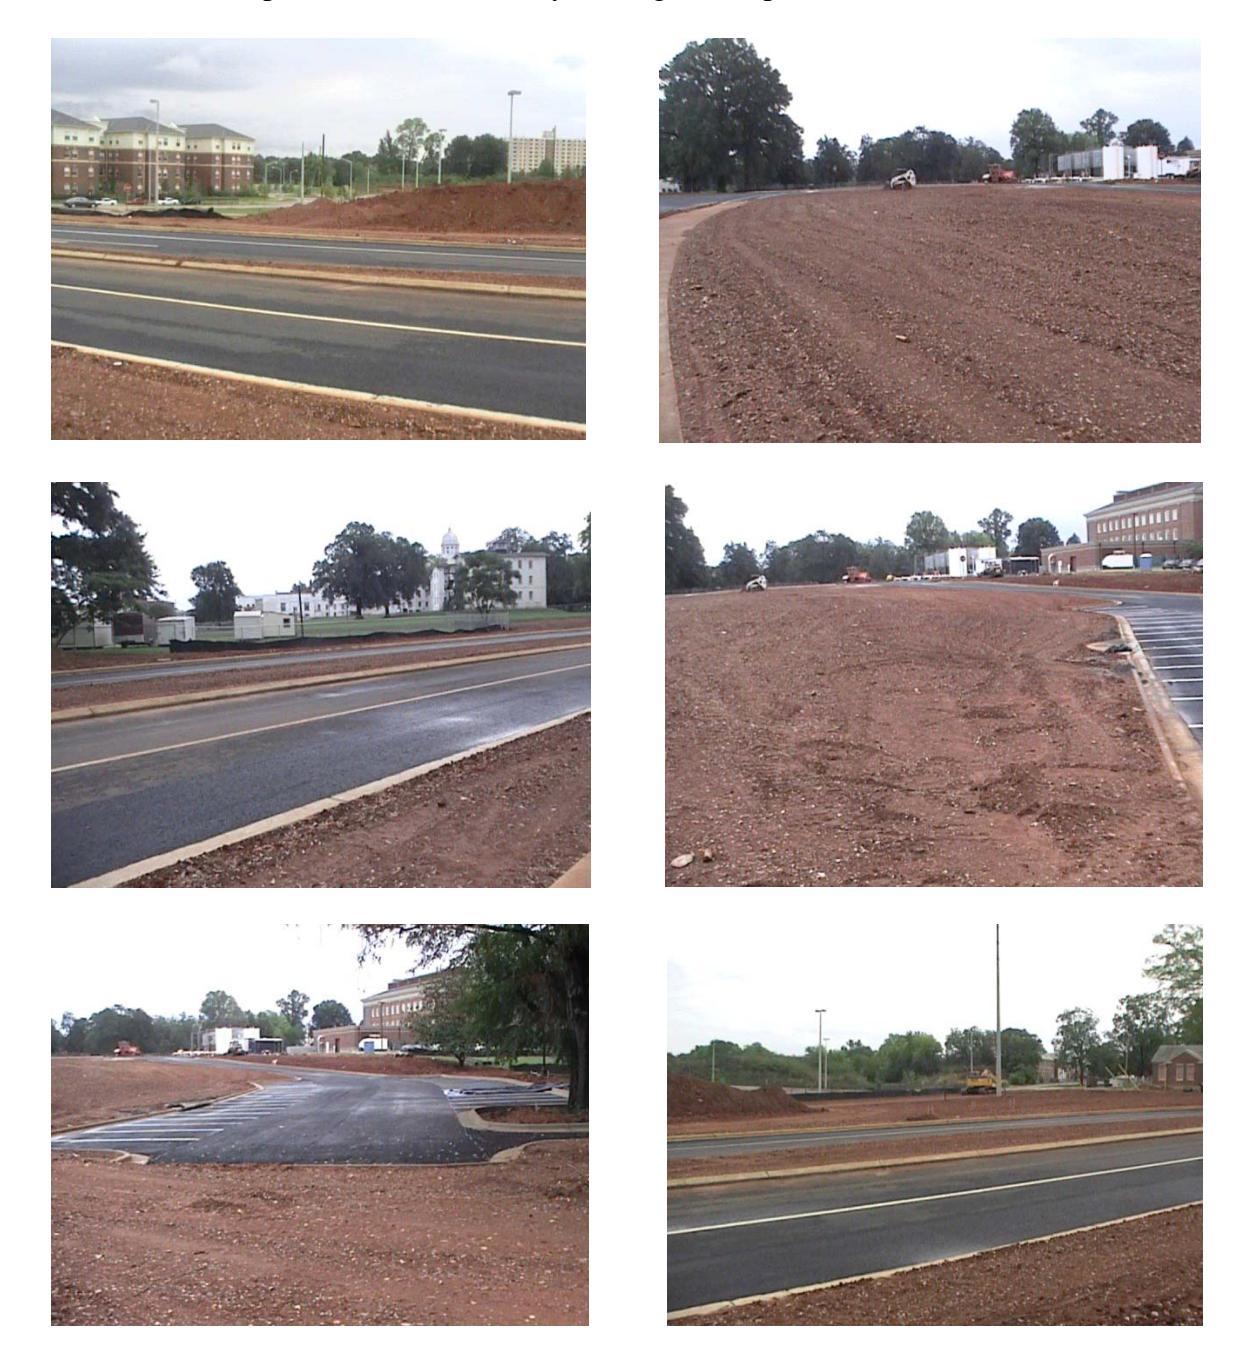
Figure 5: July 19, 2007 Photos

These photos are taken on July 19. First phase of the road construction is completed, but the parking lots for the facilities are still under construction. Photos are taken during the final period of the phase 2 improvement and bear soils are seen on the large areas of the site which has a plan to be controlled by the vegetation practice.

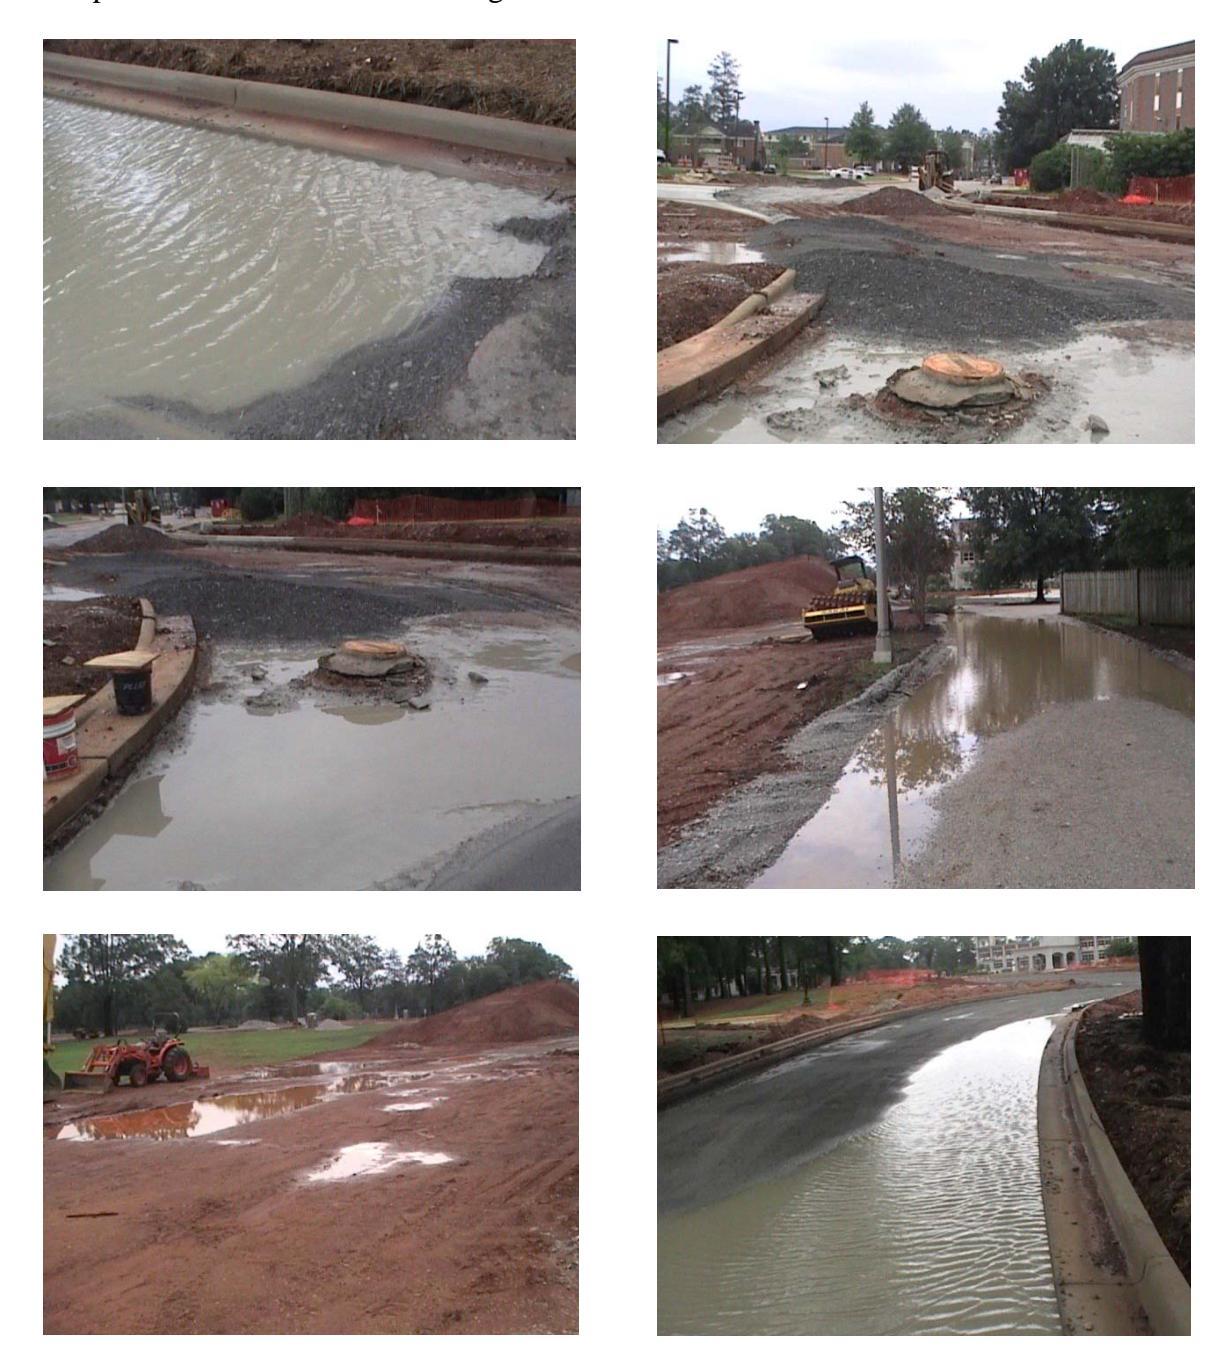
Figure 6: July 29, 2007 Photos

These photos are taken on July 29 after the storm event. Due to the storm, there are many water pools at the construction site. The storm even is occurred after the installation of the gutters and the most of runoff is prevented to runoff from the site. The stock pile is not protected well and there are huge amount of sediments runoff from it.

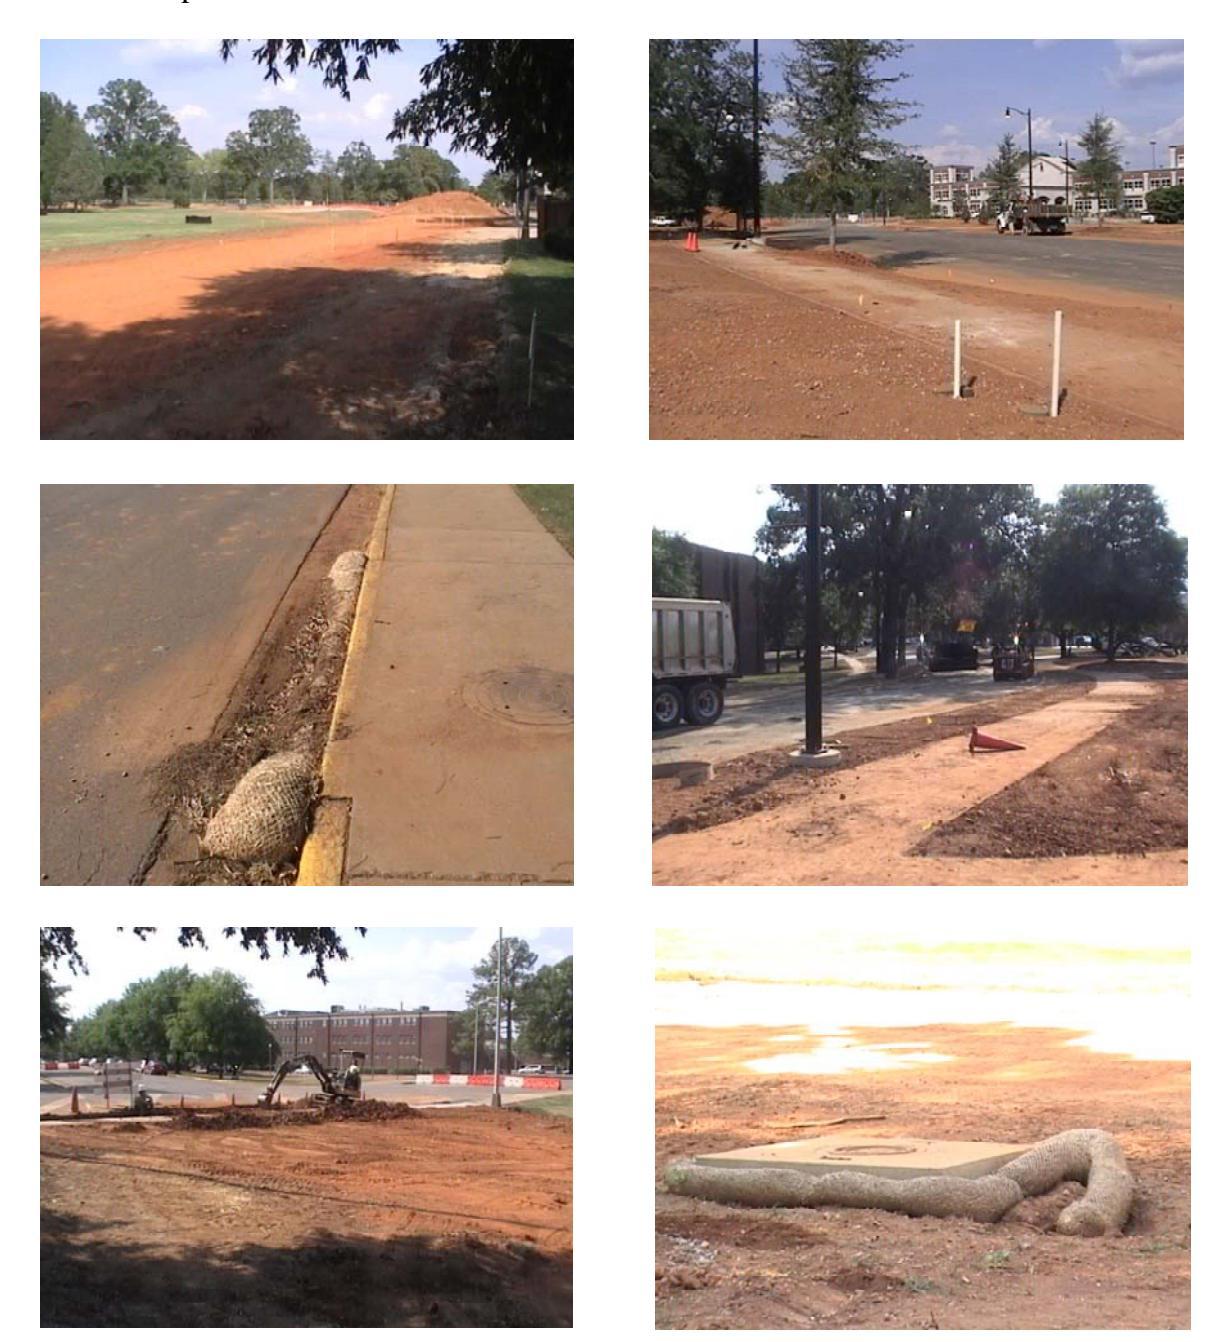
Figure 7: August 3, 2007 Photos

These photos are taken on August 3. Almost the road construction is completed including the installation of inlets and gutters. Remaining existing inlets are protected by the wattles. Permanent erosion controls such as vegetation are necessary for the bear soil surface. Most of the silt fences are removed expect the area close to the existing facilities in order to prevent the sediment runoff from the site.

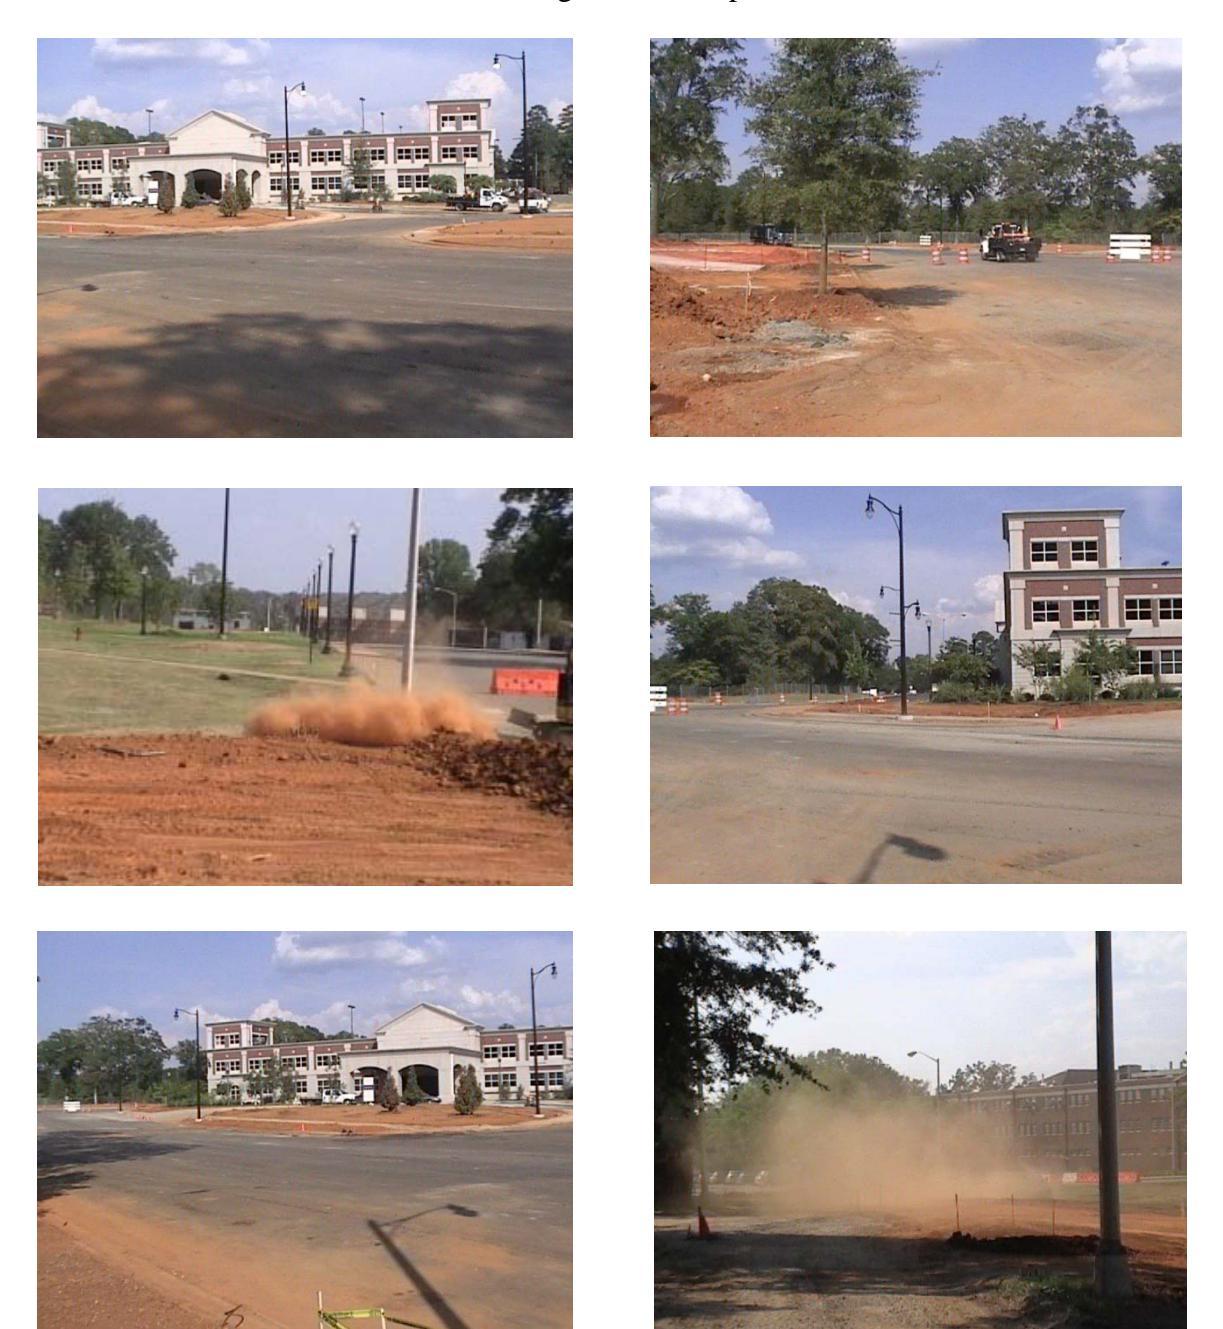
Figure 8: August 7, 2007 Photos

These photos are taken on August 7. The construction is planed to complete by August 6, but it looks like the delay in a schedule. All the road construction is completed. Due to the long period of dry days, there is a dust caused by the construction vehicles. It is necessary to spray water in order to minimize the dust. All the inlet protections and silt fences are removed and the site is waiting for the completion.
